Bridges

Karangahake had many pedestrian bridges, but not until 1885, 10 years after the opening of the goldfield.

This document is a quick gallop over some of them.

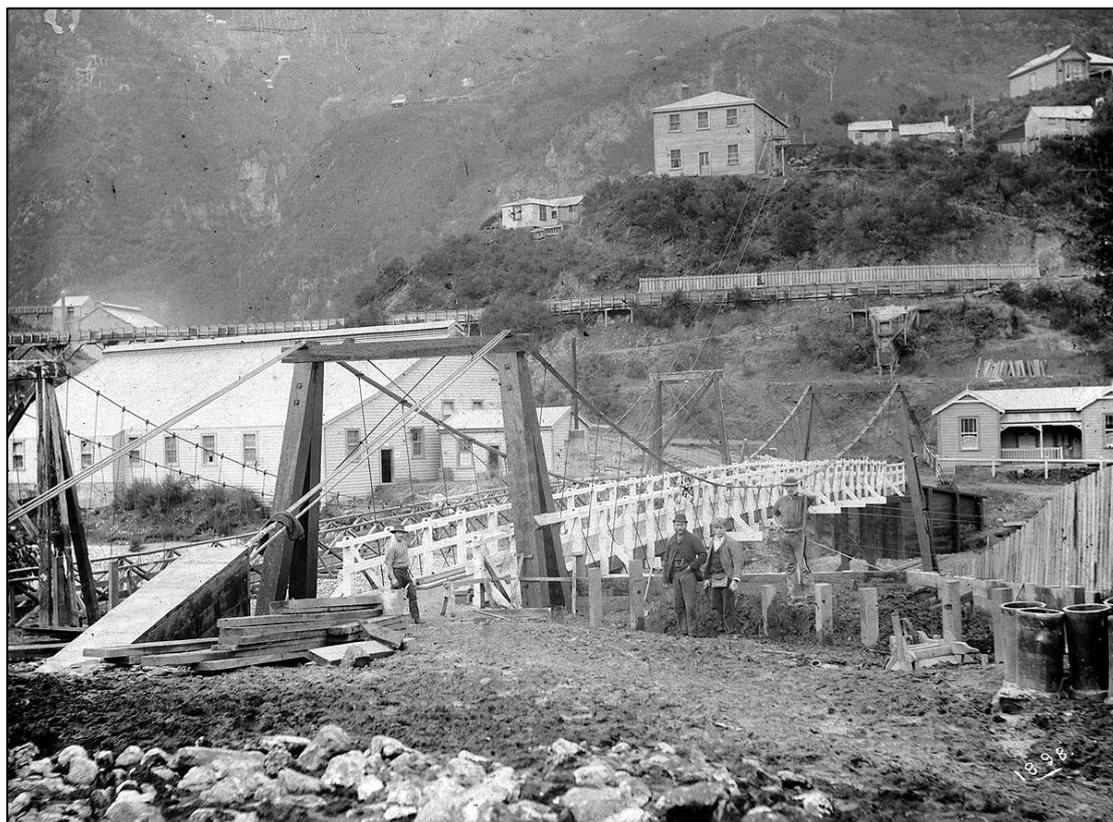
Karangahake Suspension (Traffic) Bridge under construction, 1898 (June?). Paeroa Historical Society, Staples Collection. Martin Coulson contractor on right (hardhat). Photographer unknown (MM White?). Photograph taken from the position of the present visitor shelter.

This more substantial bridge has been built a little downstream from the first bridge (1885). The substantial concrete footing for the opposite pylon is visible in the river today (below the new suspension bridge). Three cables each side.

It was more substantial than the original bridge, could accommodate wheeled traffic. It was built just downstream from the original which was left in place.

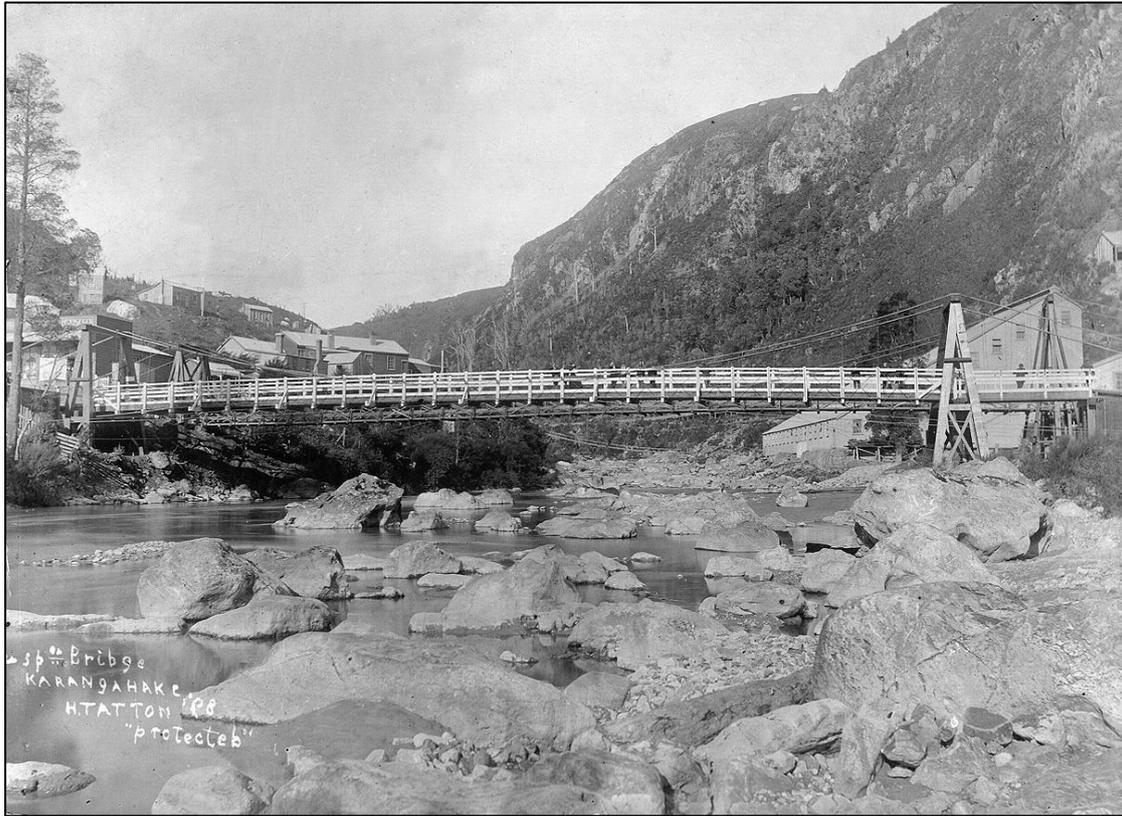
Suspension Bridge, Karangahake. H. Tatton 1898.
Seven people on the bridge.

This is the bridge between Irishtown and River Road. Built late 1897, painted early 1898.³¹

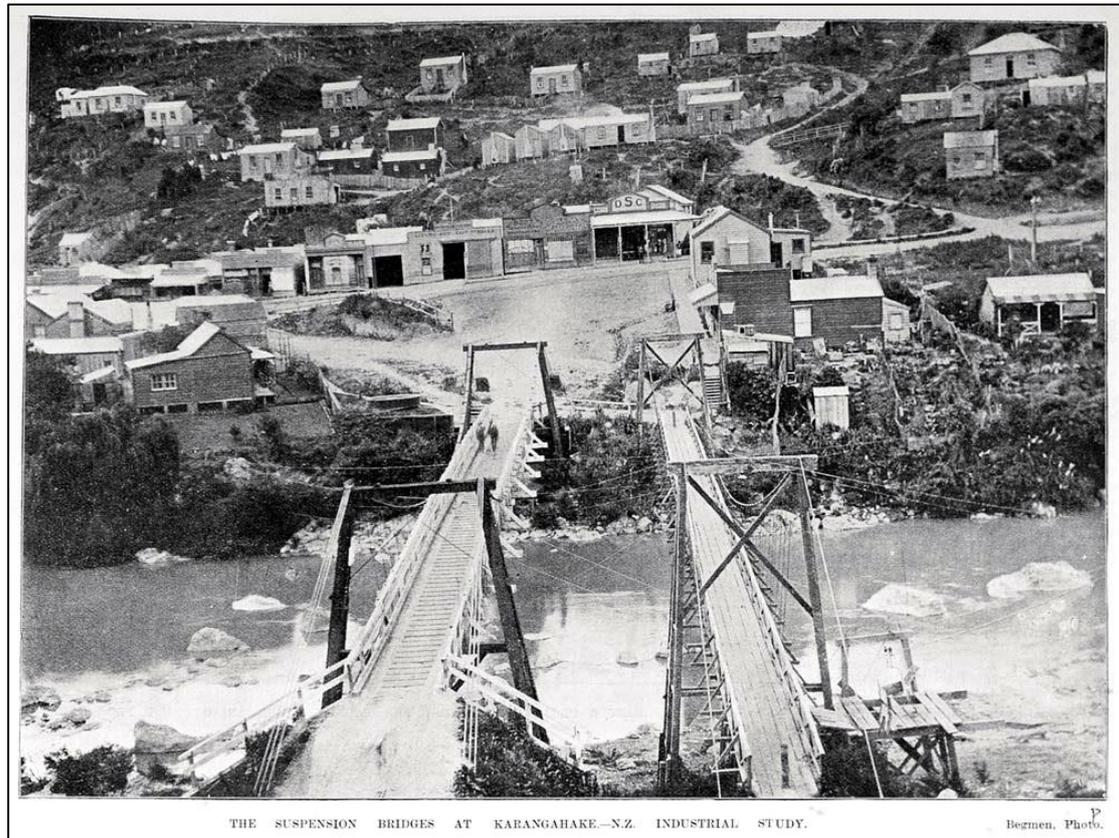
Karangahake 1910 bridges AWNS 3.5.1910. Begmen photo.

The first bridge, the right hand or upstream bridge, is replaced by a heavy truss bridge in early 1913.

The first bridge is removed before construction of the new truss bridge, but the second bridge is left as a foot bridge for some months.

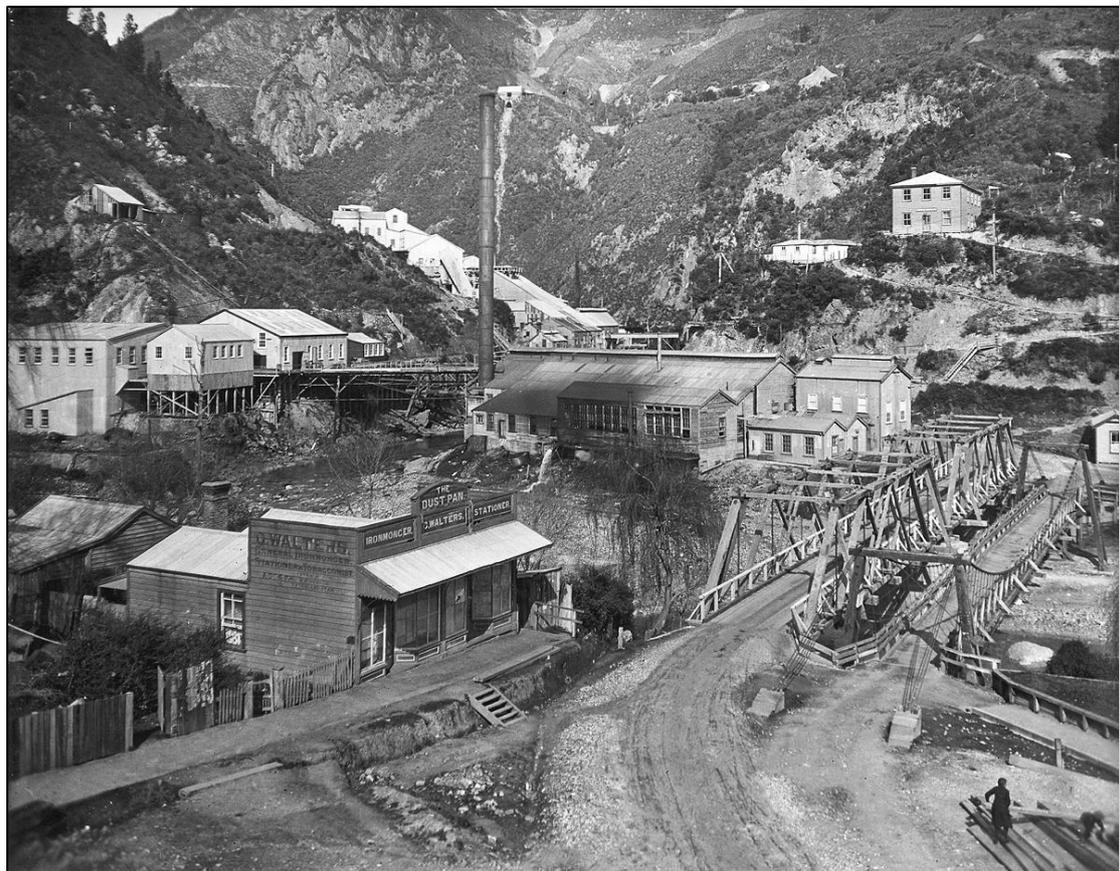
New truss bridge, with concrete centre pier, completed early 1913. It is not clear how long the second suspension bridge remained beside the new truss bridge; months, a year? There was talk of removing it to the Waitekauri Stream on the Waihi-Waitekauri Road.³⁰ But never happened?

"Re bridge at Karangahake.—I would recommend that the new bridge be erected between the two suspension bridges and that the bridge consist of two one hundred feet spans with concrete pile in the centre of the river...

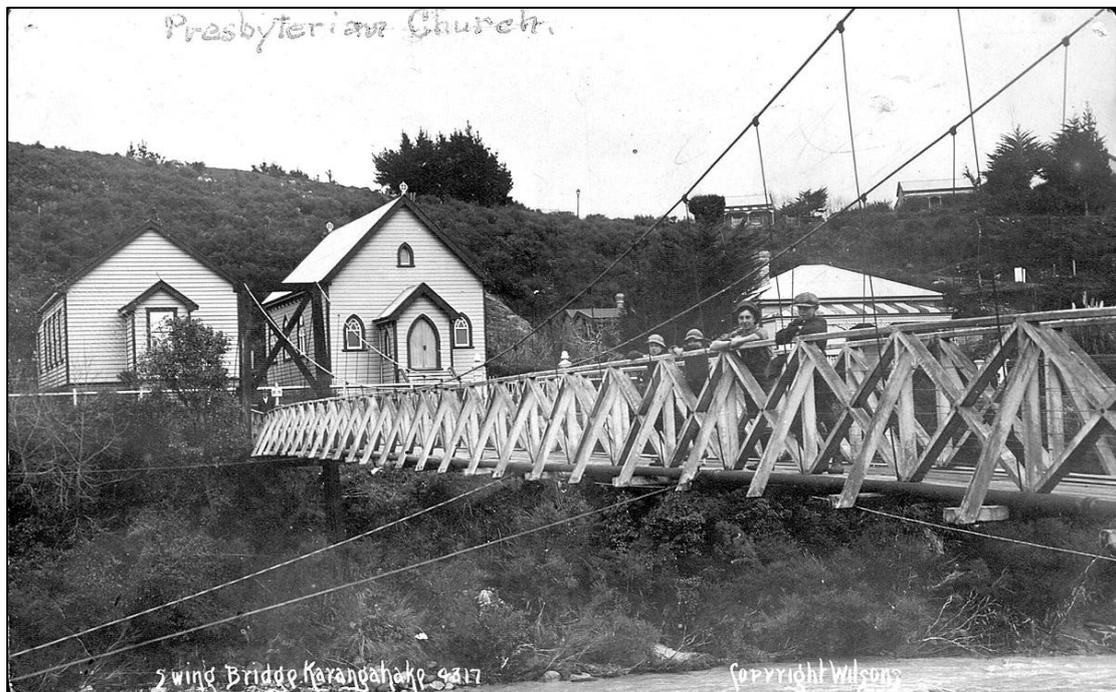
Swing Bridge Karangahake 4317. Copyright Wilson(s). Staples collection.

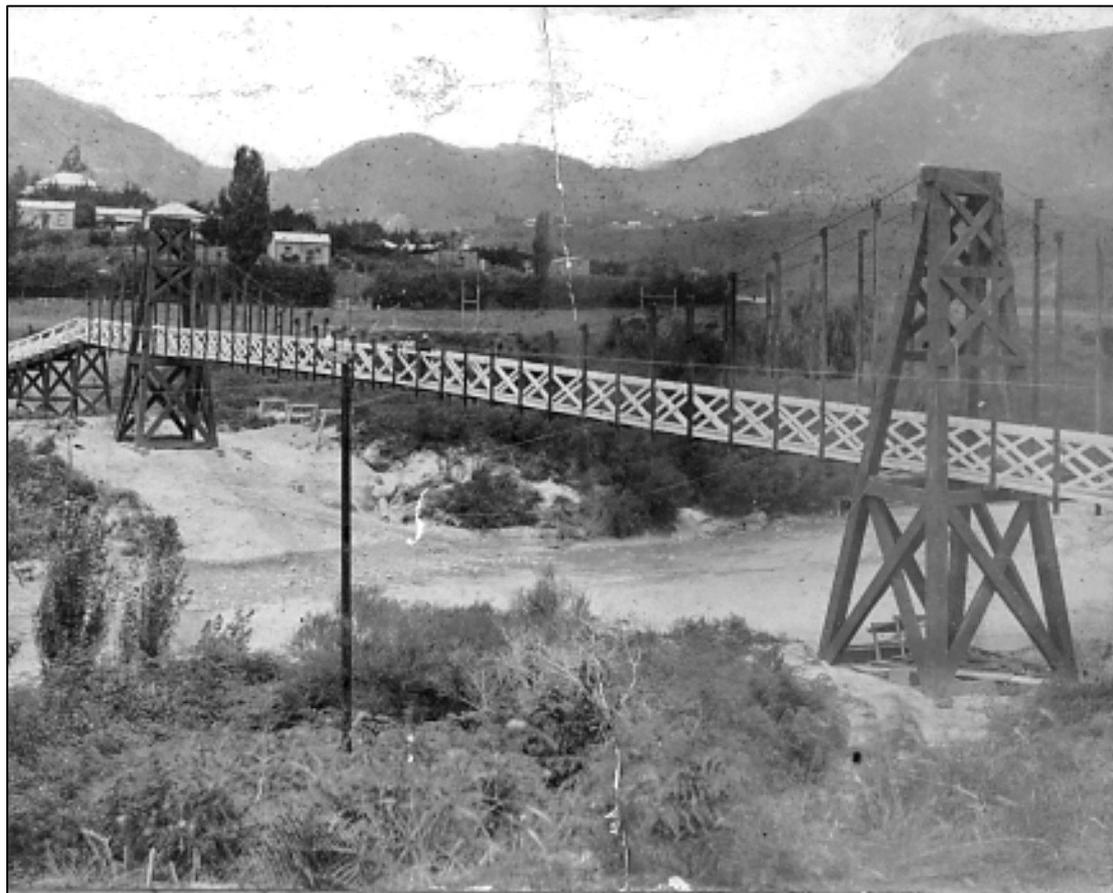
Mackaytown bridge ORHJ 50 p 34.

The pedestrian suspension bridge at Mackaytown was erected in 1906 to give access to the “flag station” on the Paeroa-Waihi railway line. In February, 1944, the Ohinemuri County Council was informed that the Public Works Department had no further use for the bridge and the council decided to demolish the structure.³⁴

Regarding the damage done by the recent flood Mr G. Bray (engineer) reported to the Ohinemuri County Council yesterday as follows:—"The recent heavy rains did a large amount of damage throughout the County... ..the Mackaytown footbridge washed out at one end...

"Mackaytown Footbridge—The timber of this bridge has been saved and will be available for the re-erection of the bridge. I would recommend that the bridge be made at least eight feet higher and 60 feet longer. The estimated cost of the work is £90."⁷⁹

MACKAYTOWN FOOTBRIDGE. COST OF RENEWING THE BRIDGE. Concerning the footbridge at Mackaytown that was blown over during the recent gale, the engineer reported to the Ohinemuri County Council at its meeting yesterday as follows:—"I have to report that during the extremely heavy south-westerly gale which blew on the 26th of last month, the partially constructed suspension bridge at Mackaytown was blown down. In its descent the bridge caused an undue strain of a twisting nature upon the hooks of the union screws where they hung to the anchor rods, and when finally getting under the influence of the strong river current, the bridge tore open these hooks..."⁸¹

There was some dispute about responsibility for the disaster, but it appears that the bridge was rebuilt. It lasted till damaged by floods 1936.⁸²

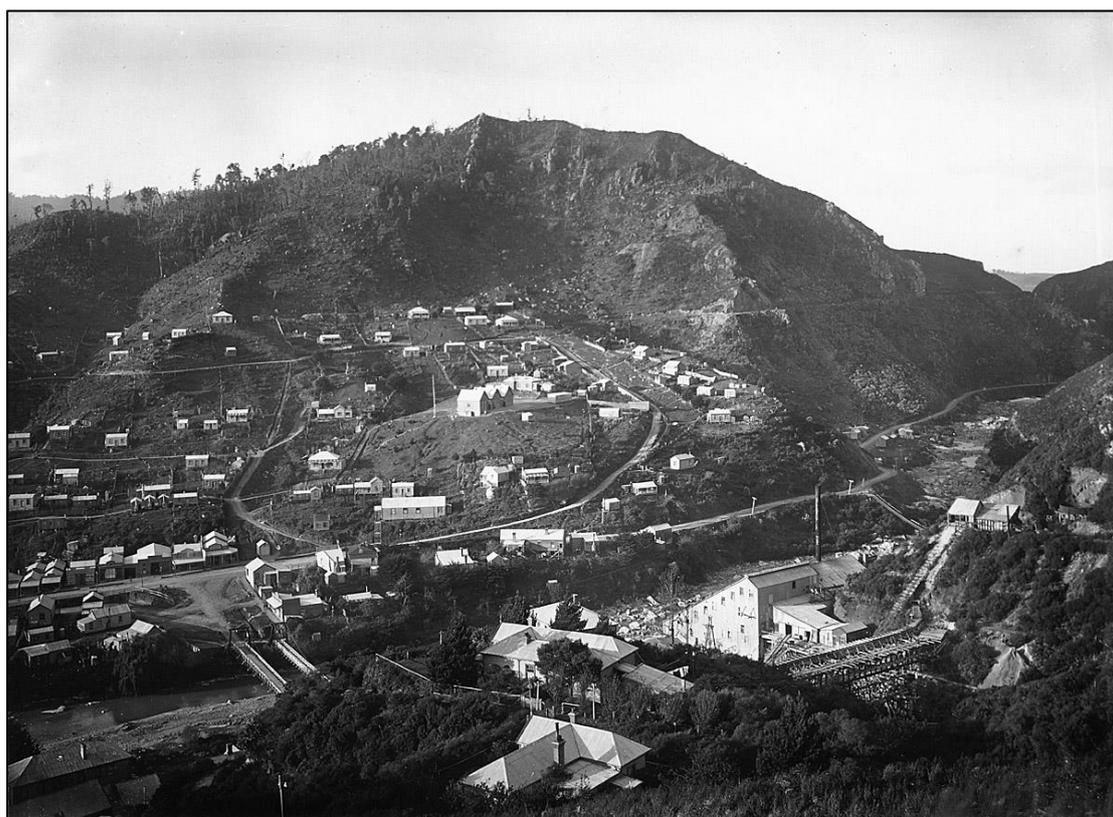
1906? Winkelmann photo, taken from the County Road? Staples collection.

The bridge across the Ohinemuri, used to bring material to the battery during construction can be seen to the right of the Woodstock battery. It appears to be a swing bridge rather than a suspension bridge.

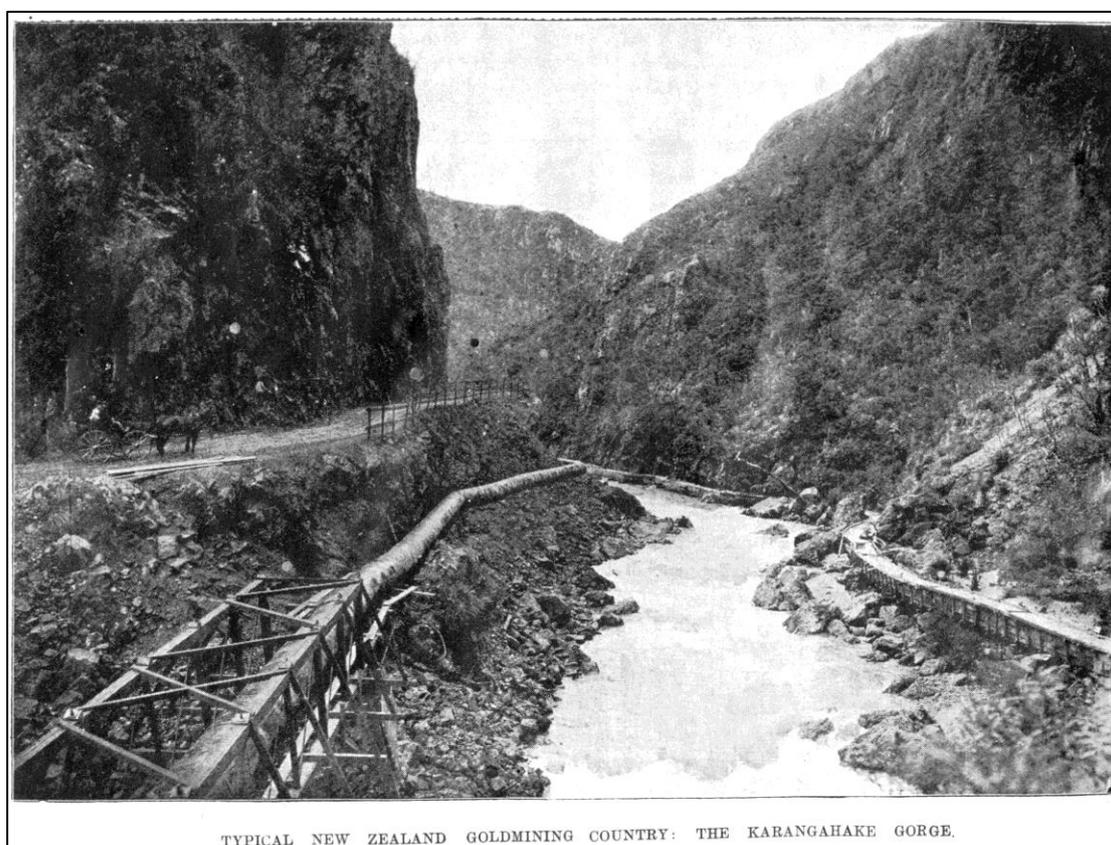
Auckland Weekly News 1901. Looking upstream from the true left bank of the Ohinemuri. The pipeline takes water from the new dam a little upstream from the later to be constructed Eastern Portal rail bridge. At the right of the image is the Crown Company water race flume, taken from a dam just upstream out of the image.

At the Woodstock mine the work of extending the main pipe-line between the new dam and the mill is being actively carried on...³⁸

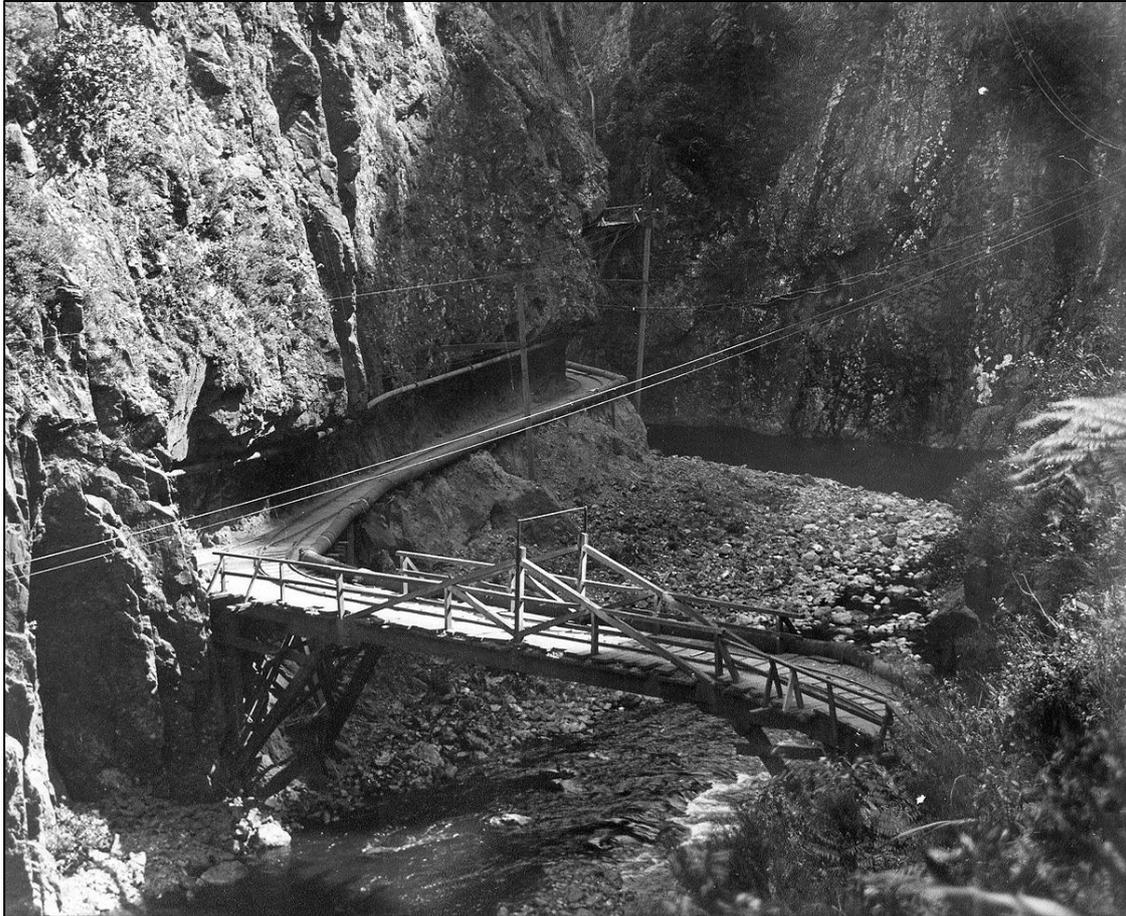
Crown tramway wooden bridge over Waitawheta River

Staples collection. Date of this image not known. George Chappell?

Looking downstream.

Evidence of the bridge is still to be seen here, with cut-outs in the rock for the timbers. This bridge was replaced by a suspension bridge when the Paeroa municipal water supply pipe was installed (c. 1959), and again May 2021 by the Department of Conservation.

This bridge was replaced c.1958 by a suspension bridge to accommodate the Paeroa municipal water supply pipeline, continuing as the walkway bridge, until this was also replaced in 2021 by DoC.

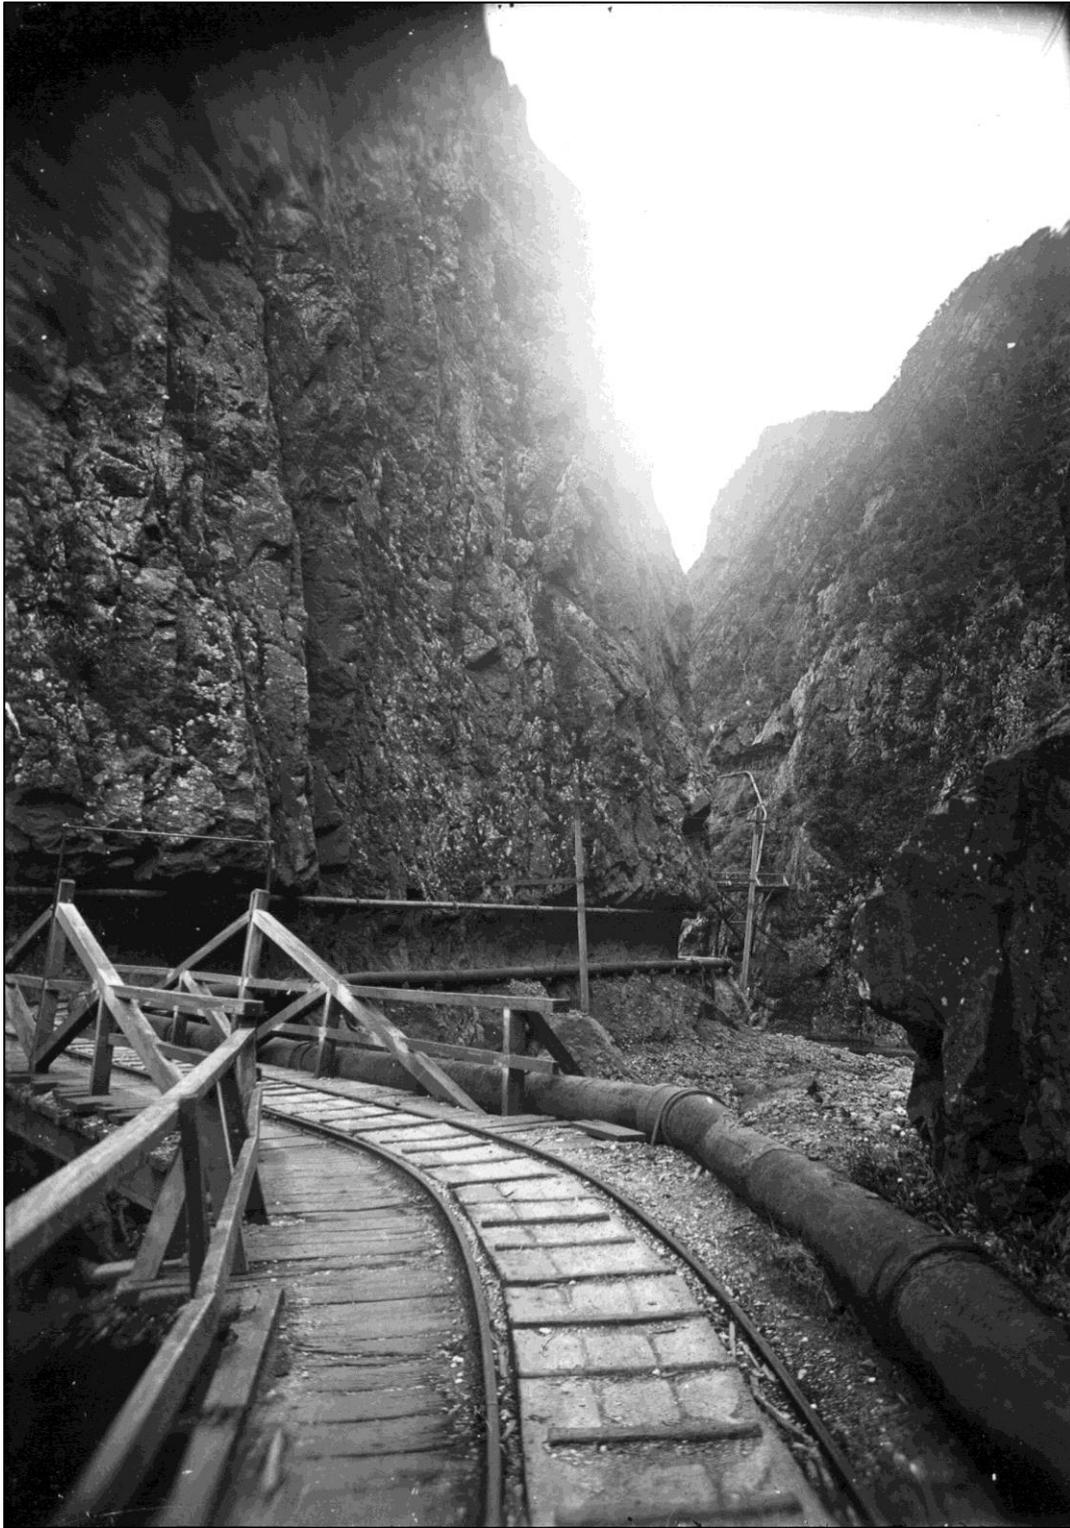
George Chappell photograph. Looking downstream.

The wood between the rails to allows for the horses that transported the ore carts to the battery. The large pipe at right took water discharged from the large pelton wheel at the mine entrance to the battery where it was able to do more work.

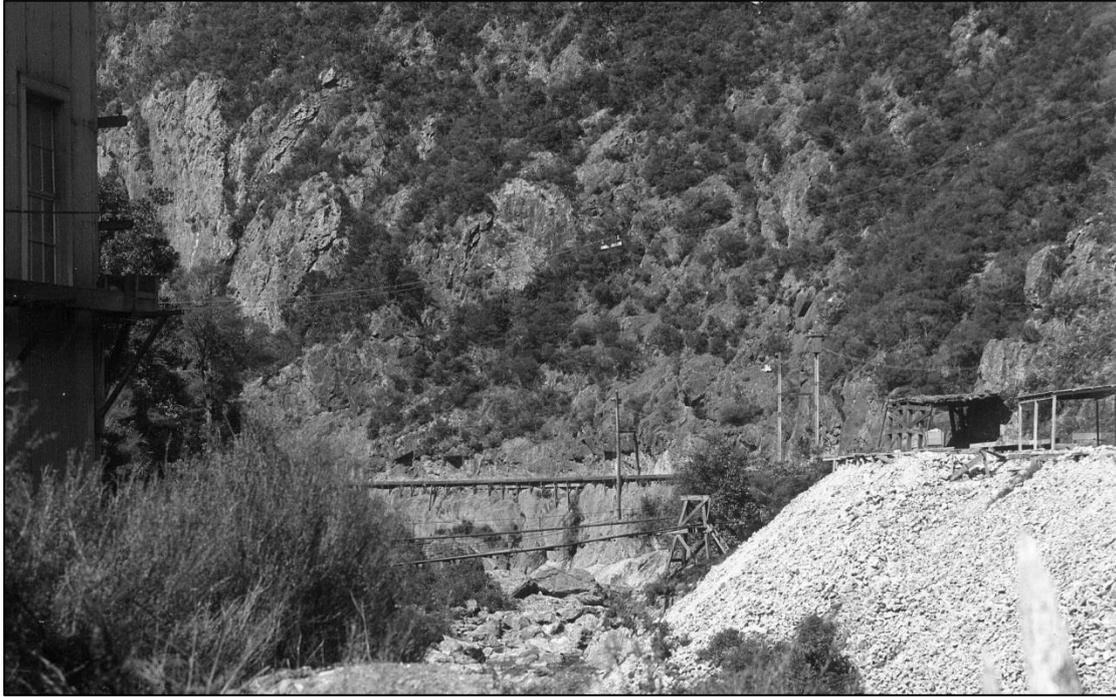
Suspension bridge at Talisman battery

Talisman Gold Mining Battery, Waitawheta Gorge, Karangahake Nat Lib. George Chappell.

We are looking upstream on the Waitawheta River, corner of the Talisman battery at left, Crown tramway with pipe on right and background. A suspension bridge crosses the river. Pipes and other cables cross also.

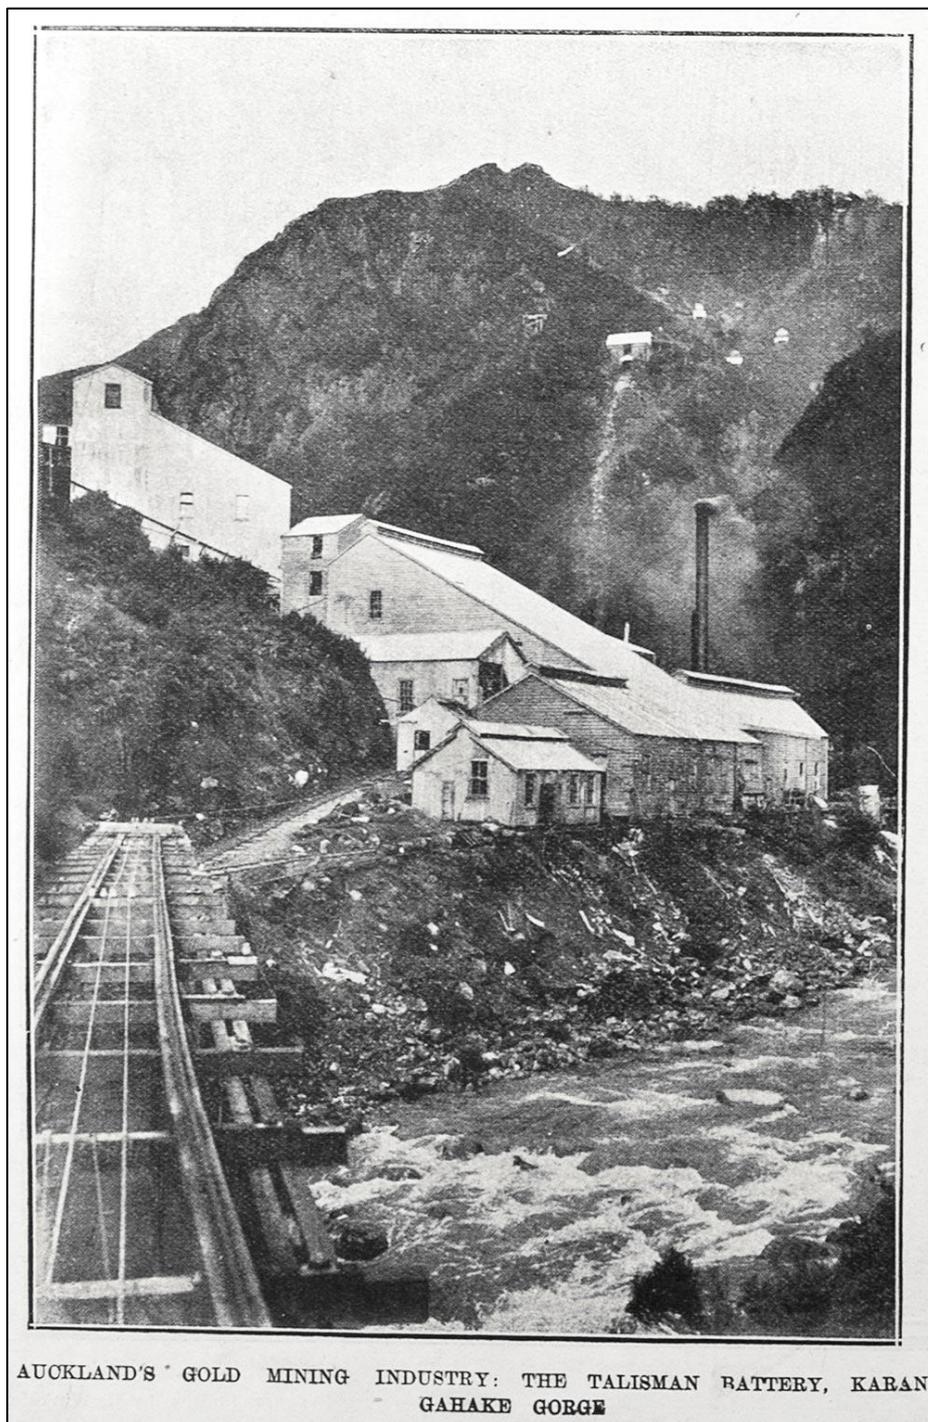
This is a double-decker bridge, installed at an angle across the Waitawheta River. The concrete mounts remain.

AWNS_19040707_p010_i004_b 07 JULY 1904 Auckland Library.

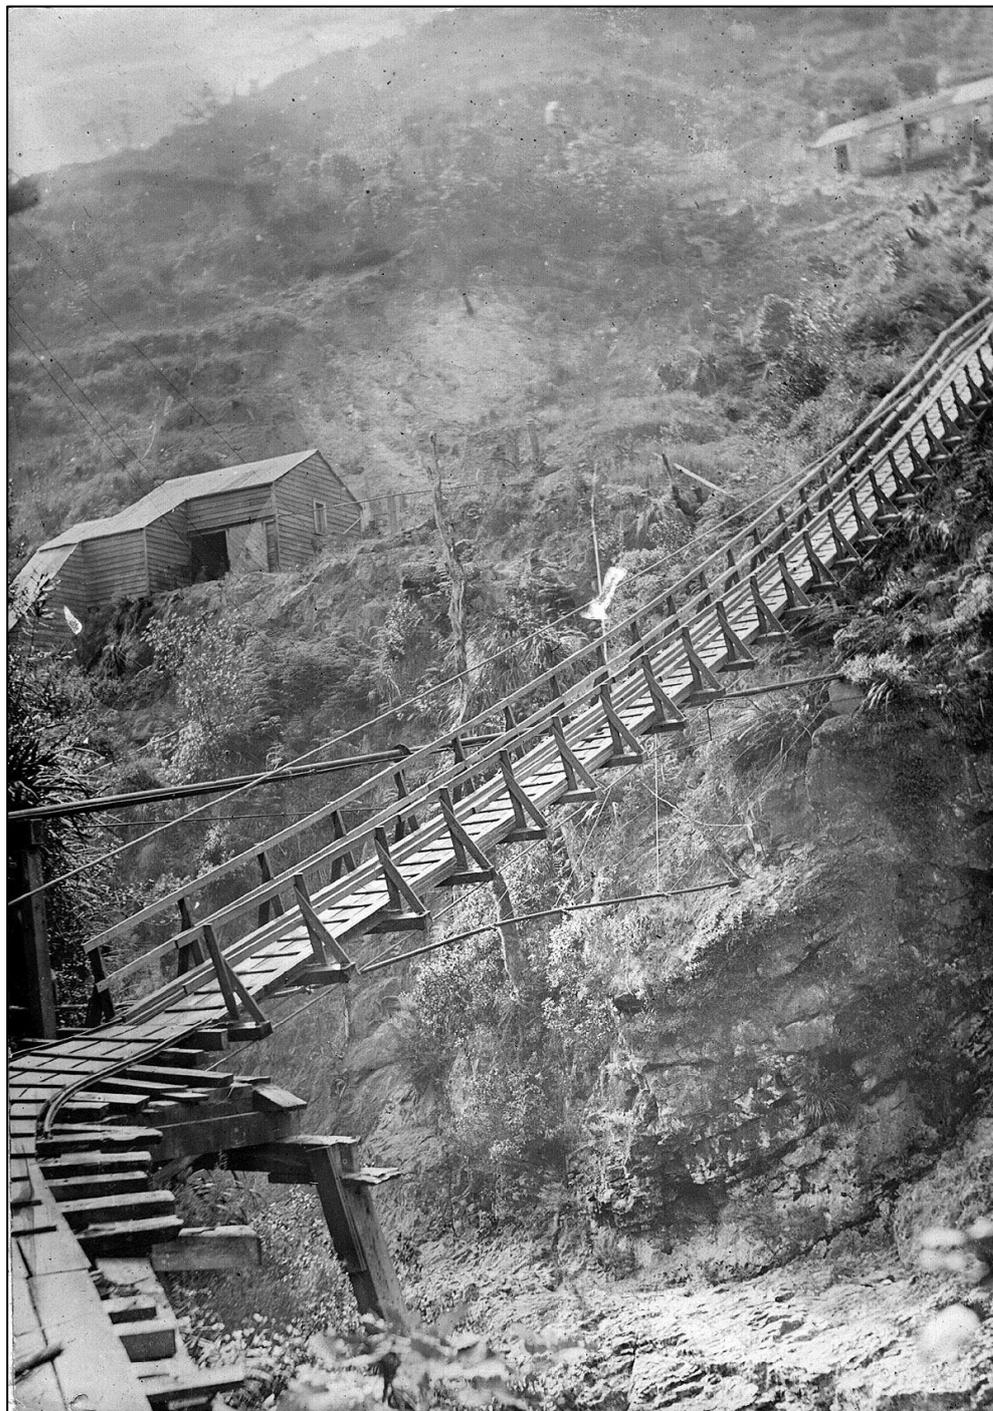
There is no hand rail on the bridge, a luxury that was added later. Workmen, not prepared to risk a fall from the bridge, cross the river on a low log bridge, and scale the cliff by ladder. The wire used to haul ore across the river can be seen. This wire, or one of the bridge wires, is present today.

Compressor and swing bridge. Staples collection. The compressor was completed March 1894.⁴³

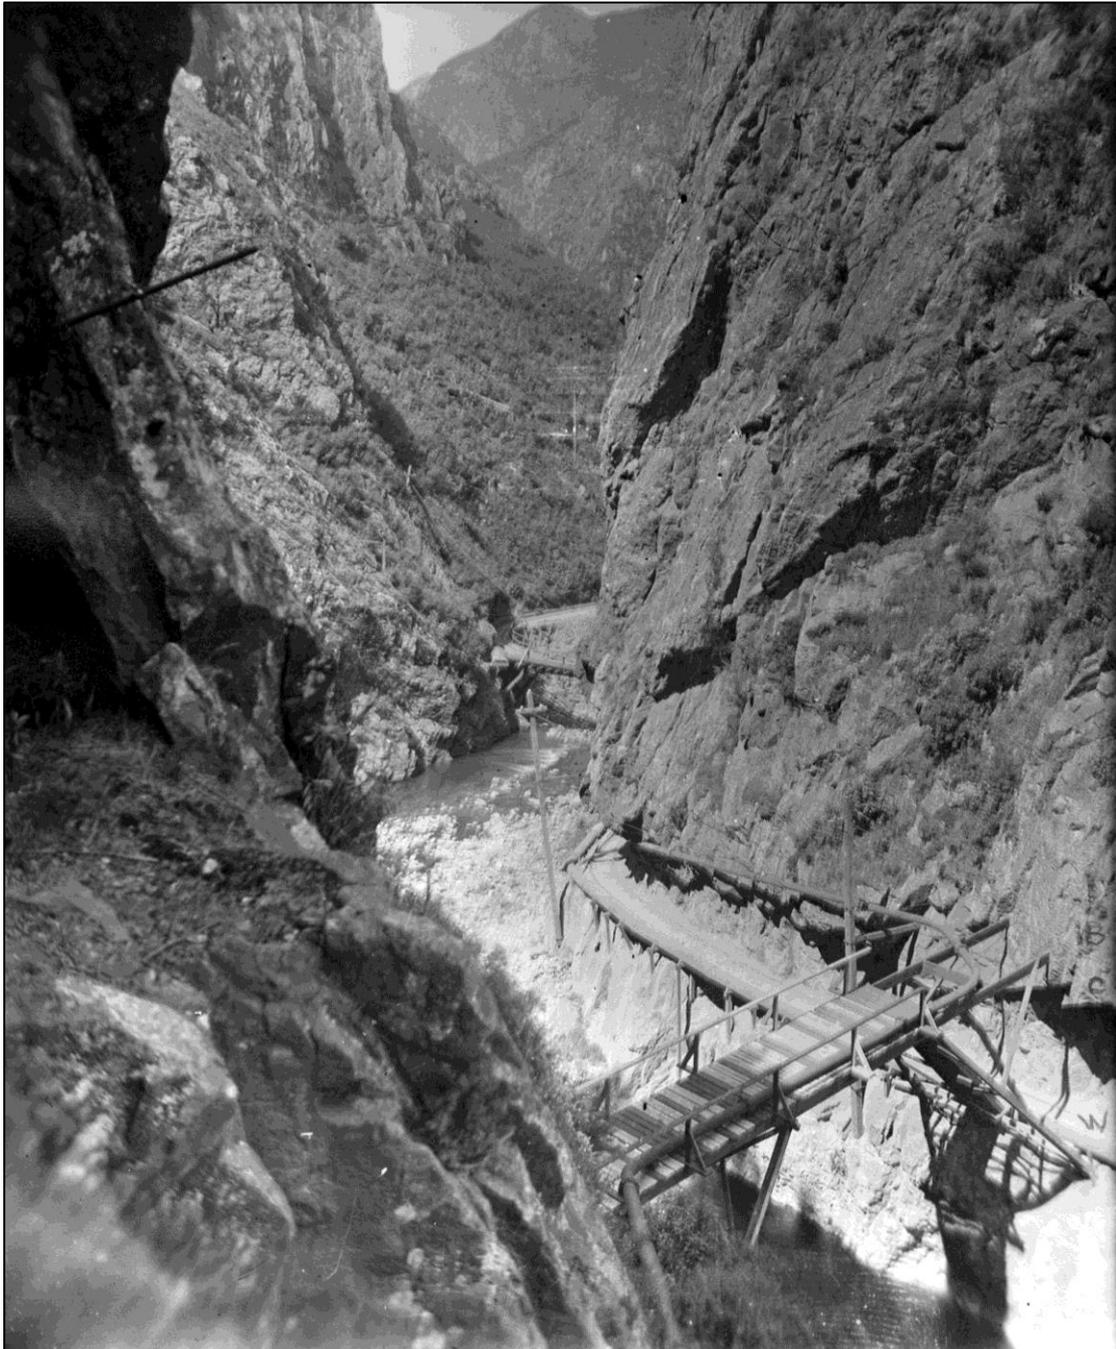
Staples collection. Date undetermined.

We are looking upstream, Waitawheta Gorge. In the foreground the compressed air pipe on its supporting bridge. The photograph is taken from one of the “windows”, a precarious undertaking, hence some camera shake is present in the image.

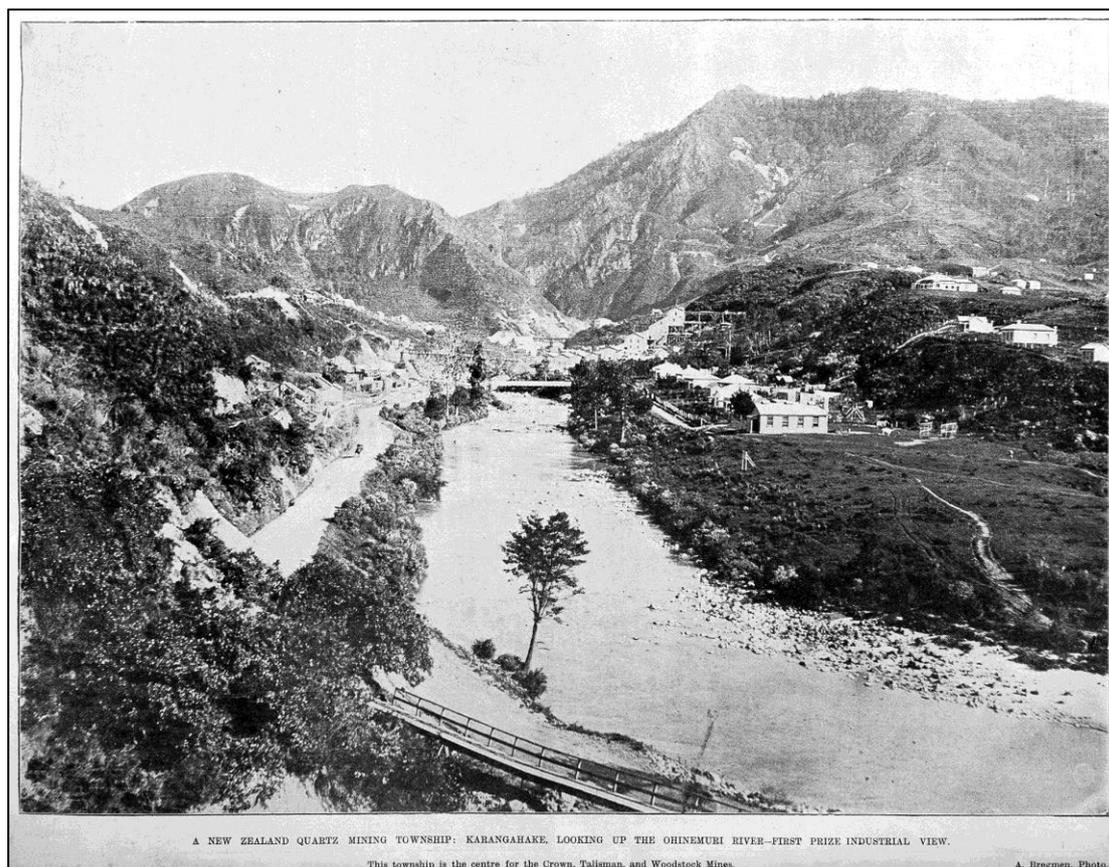
1901 05 03 Auckland Libraries Heritage Collections AWNS-19010503-01-02 A Bregmen.

Although a poor quality image, beyond the River Road bridge, the temporary bridge can be seen, and the pile of mullock on the Crown battery side of the river.

In the foreground of this image is the Dougherty’s Creek footbridge. The road itself crosses the creek by ford. This ford is not replaced until 1920.

The road/rail double-deck bridge gets built after the tunnel has been started, ie it is not used to get the tunneling underway, or to get the spoil into the river. A temporary bridge is used at first. “The temporary bridge over the Ohinemuri has been completed. This will admit of the spoil from the tunnel excavation being conveyed across the river and there utilised in the formation of the station-grounds, &c”⁴⁸

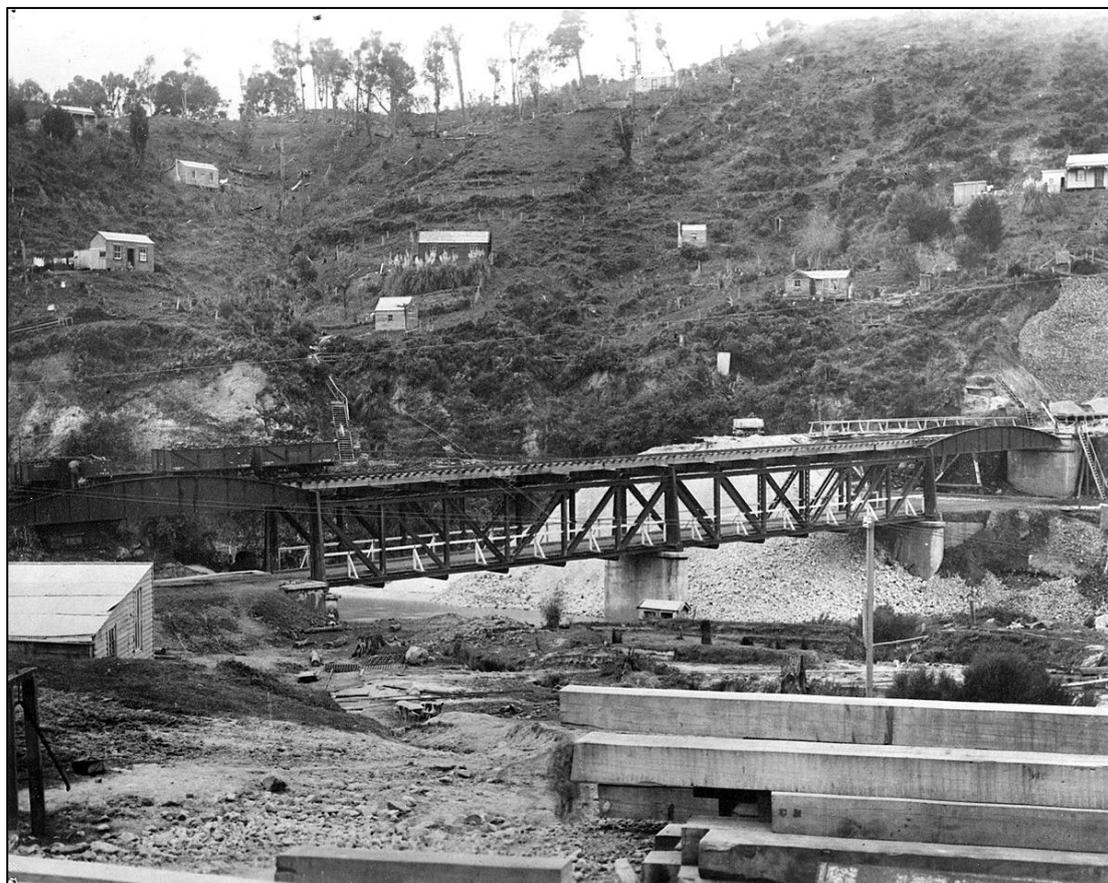
Western portal railway bridge

West portal rail bridge under constr, c1903 ATL. DoC Thames.

Photograph taken from the Crown battery.

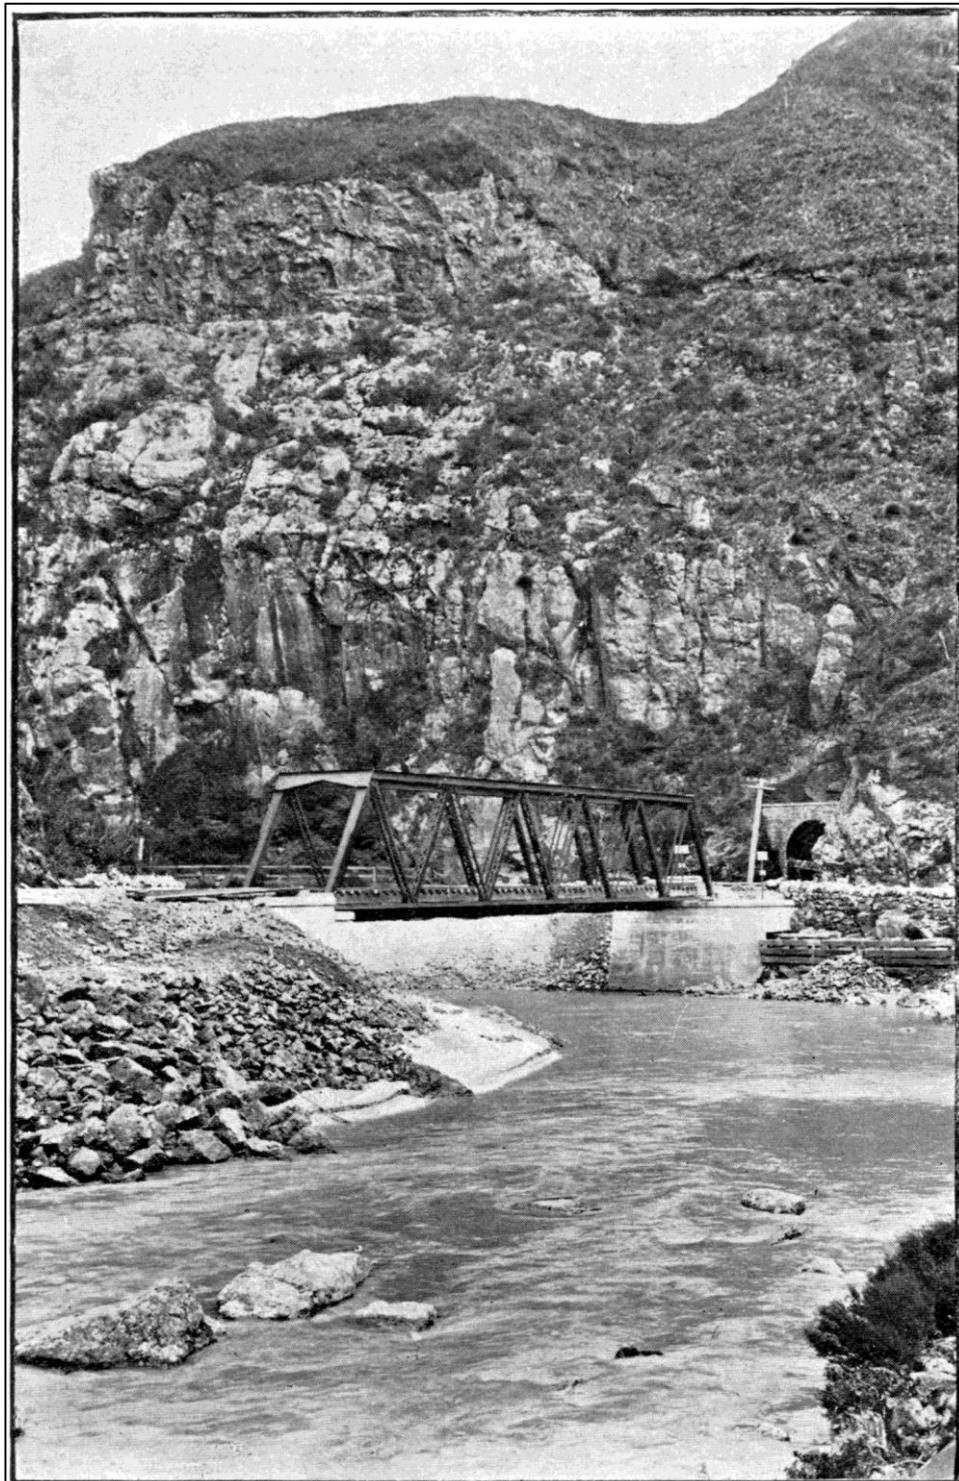
Completed end of 1904 or beginning 1905.

BRIDGE SPANNING THE OHINEMURI RIVER.

Showing tunnel entrance on the Paeroa-Waihi Railway.

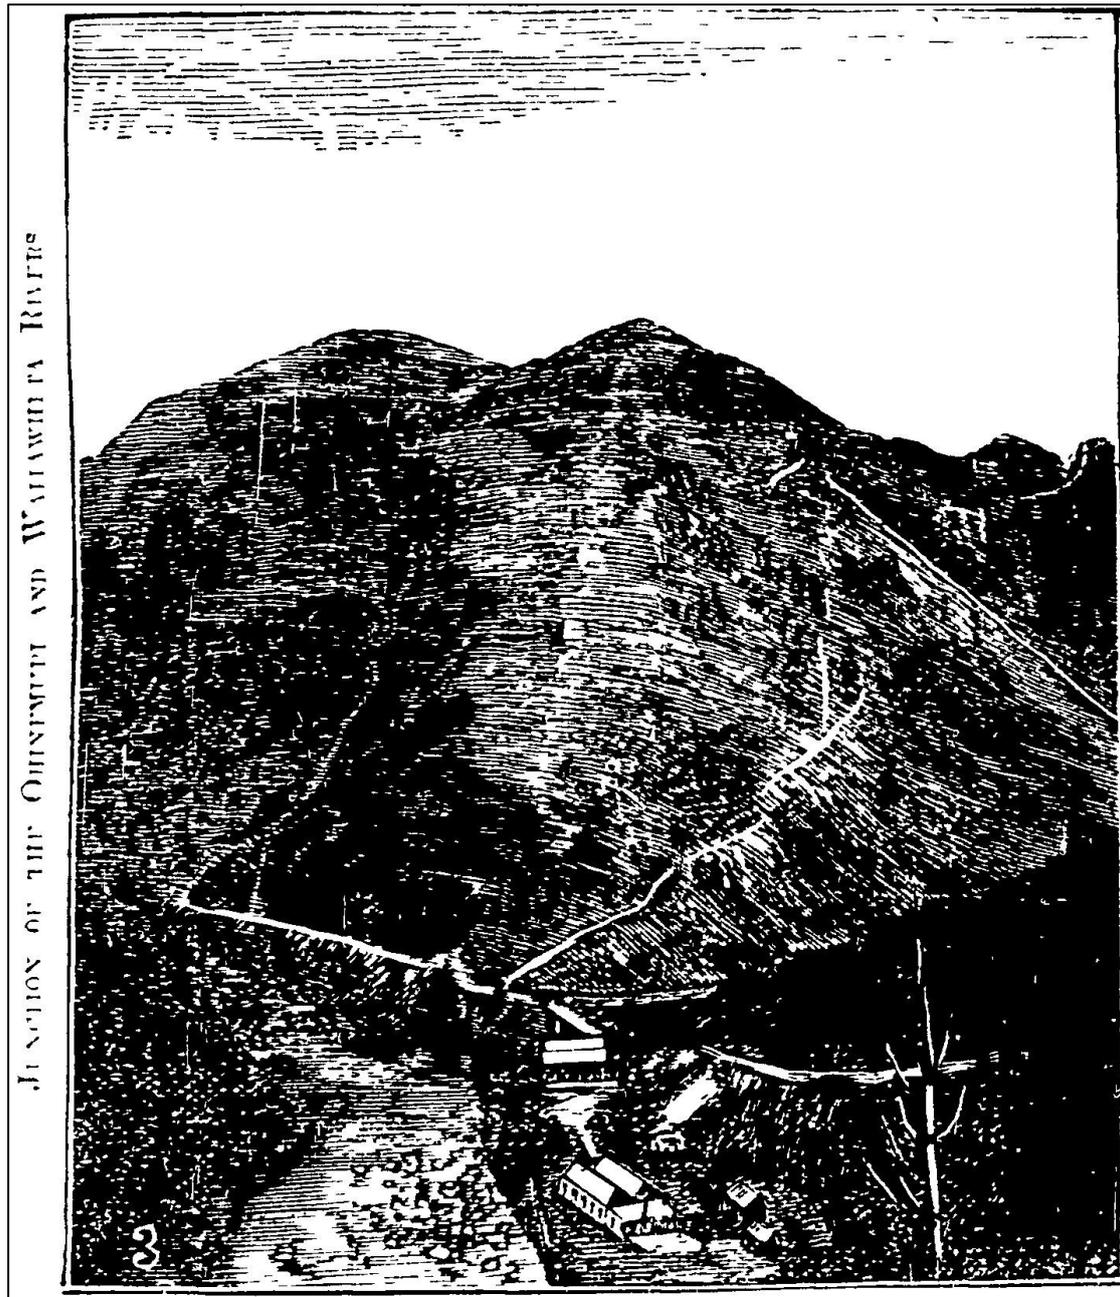
Pictorial Christmas Supplement to the New Zealand Herald, December 1885.⁵⁷

Image 3 shows the hotel in the foreground, Karangahake battery beyond, and the water race flume crossing the Waitawheta River beyond that. This is the earliest image, 1885. By this date there is also a tramway trestle bridge crossing the Waitawheta River. See below.

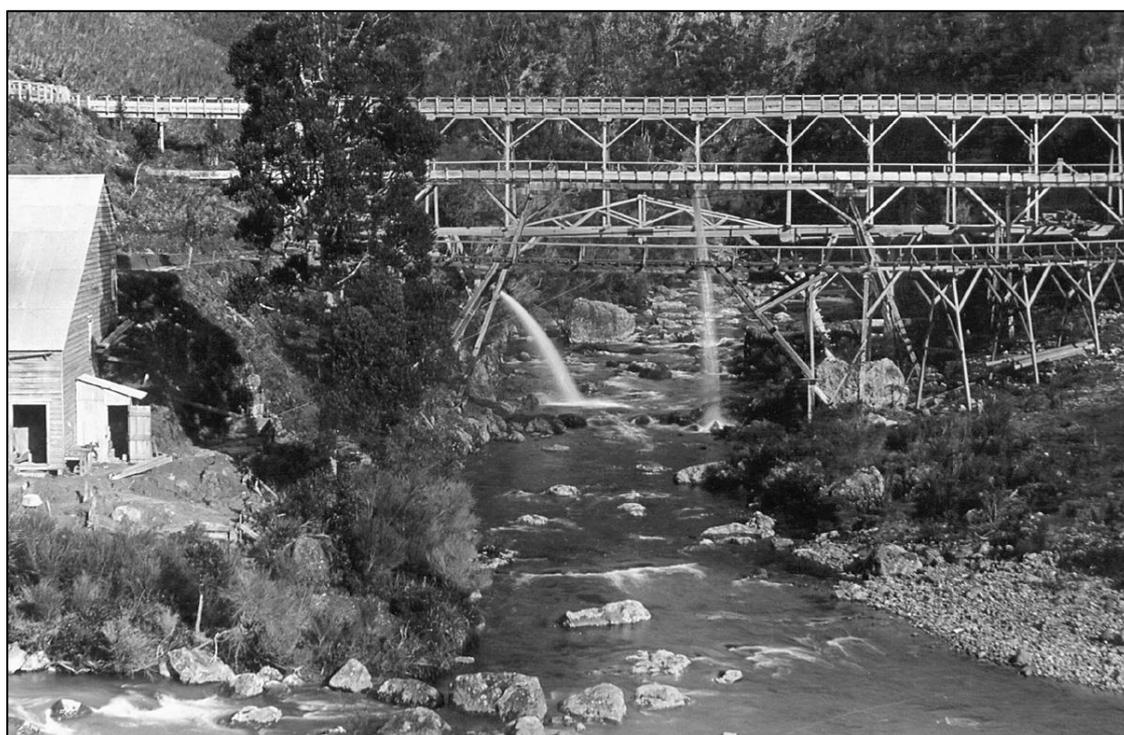
This appears to be the earliest image of the Woodstock furnace, and Crown battery flumes crossing the Waitawheta at the confluence. M.M. White photograph B3575. 1892-4.

The top flume is the Crown water race (1892) which we should ignore in this instance. It adds confusion because it has a lower level with a distinctive A-frame support in the middle. It is intended to provide tramway connection across the river.⁶⁵

The span of 90 feet is across the Waitawheta River.
