Bridges

Karangahake had many pedestrian bridges, but not until 1885, 10 years after the opening of the goldfield.

This document is a quick gallop over some of them.

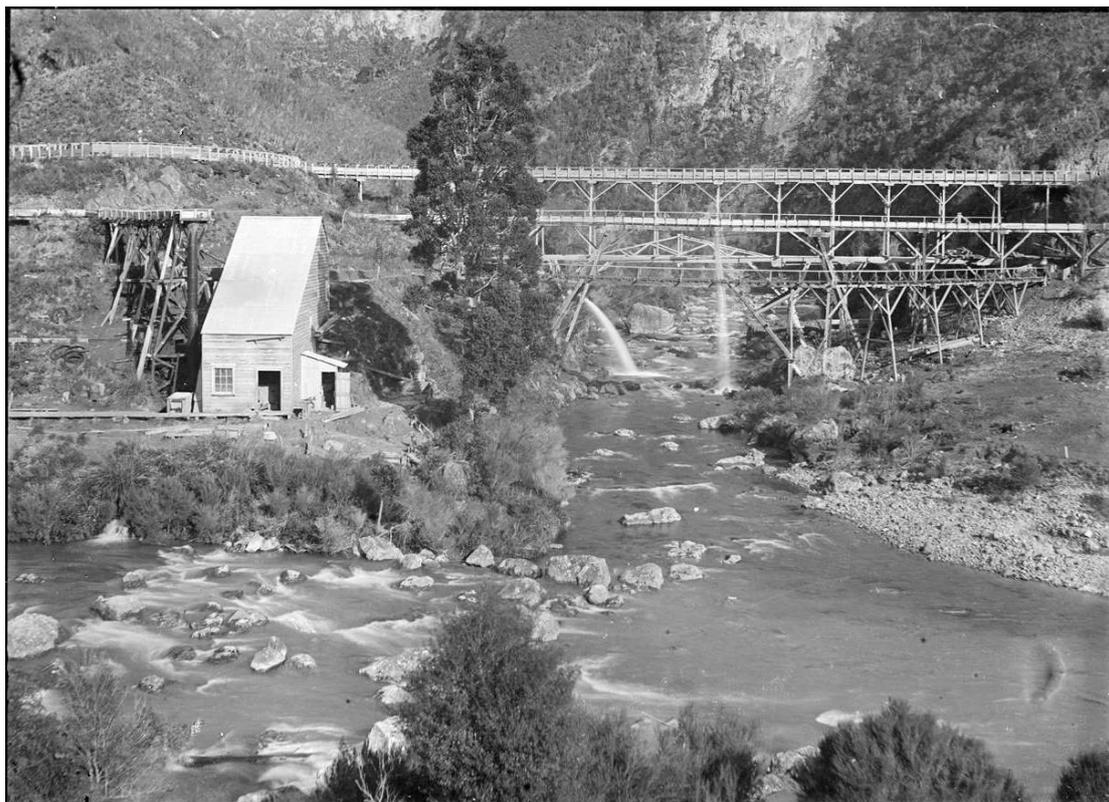
M.M. White photograph B3575. 1892-4.

The same image as above. The top flume is the Crown water race (1892). It has a lower level with a distinctive A-frame support in the middle which is intended to provide tramway connection across the river.

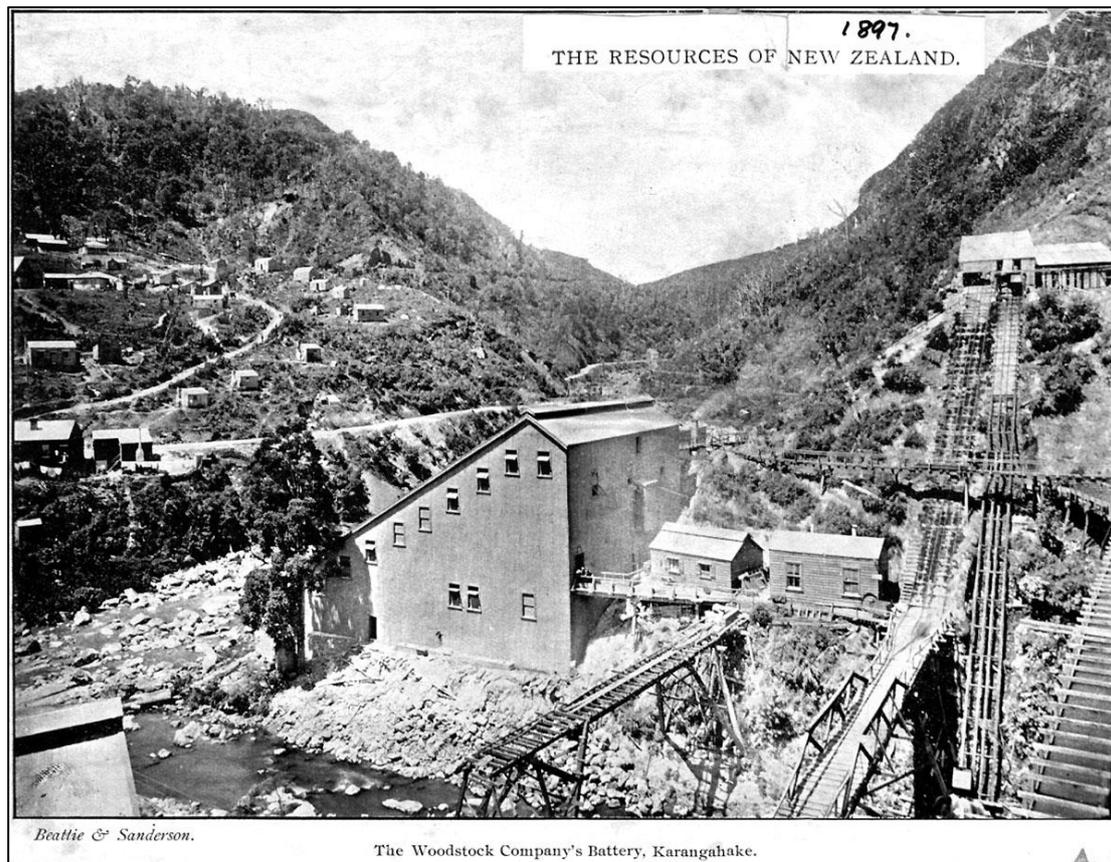
Someone has dated this image 1897. It is certainly before the boiler and engine were added. The bottom left corner of the image shows the Talisman vat house, completed June 1897.

The 40 stamps are housed in the tall section of building. Dry crushing, so many windows are open, and a white dust surrounds the building.

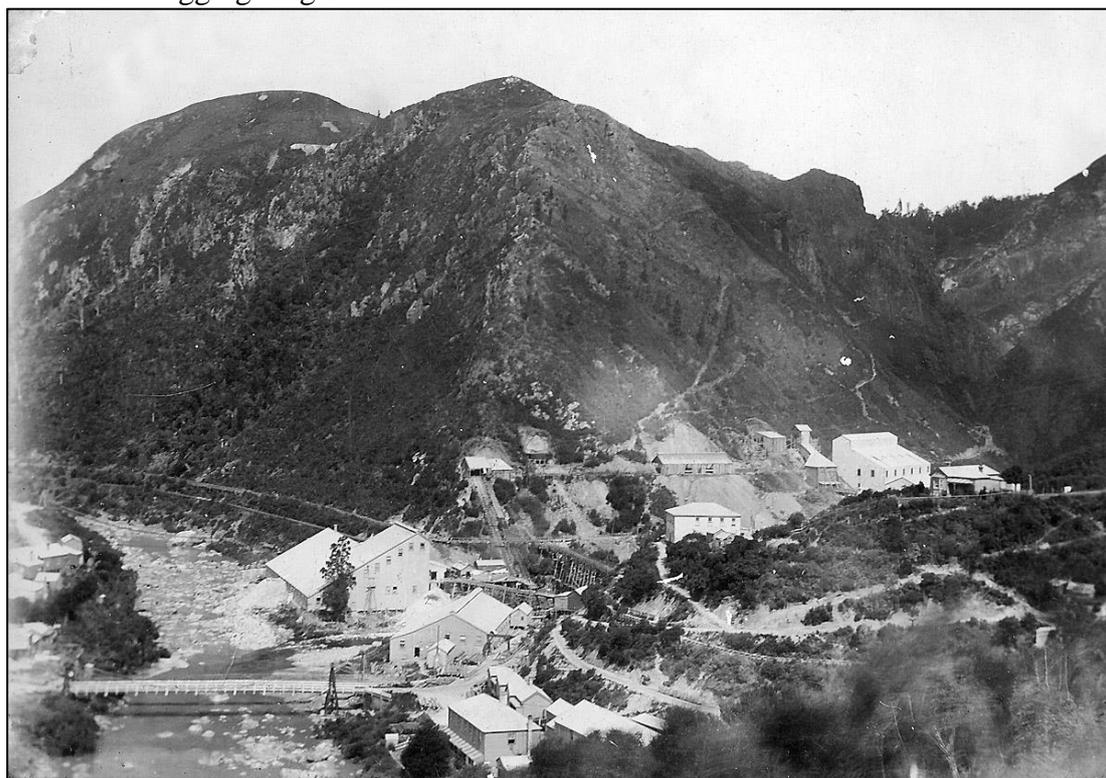
The new Talisman battery is complete, so late 1900 or 1901 or 1902. There is no large chimney on the Woodstock battery; this was erected early 1901⁷². The photograph is taken from the County Road.

The Traffic Bridge, beside the original suspension bridge, constructed late 1898.⁷³

The old bridge across the Waitawheta Stream (connecting the battery with mine tram-line) has been taken down, as it was much decayed and too light for the economical ore-supply to the battery. A new and more substantial bridge going direct to the battery ore-hopper has now been almost completed. This bridge is 180 ft. long over all. It is designed for the transmission of horse and

train of trucks as they come from the mine, and will carry such a distributed load aggregating 10 tons.⁷¹

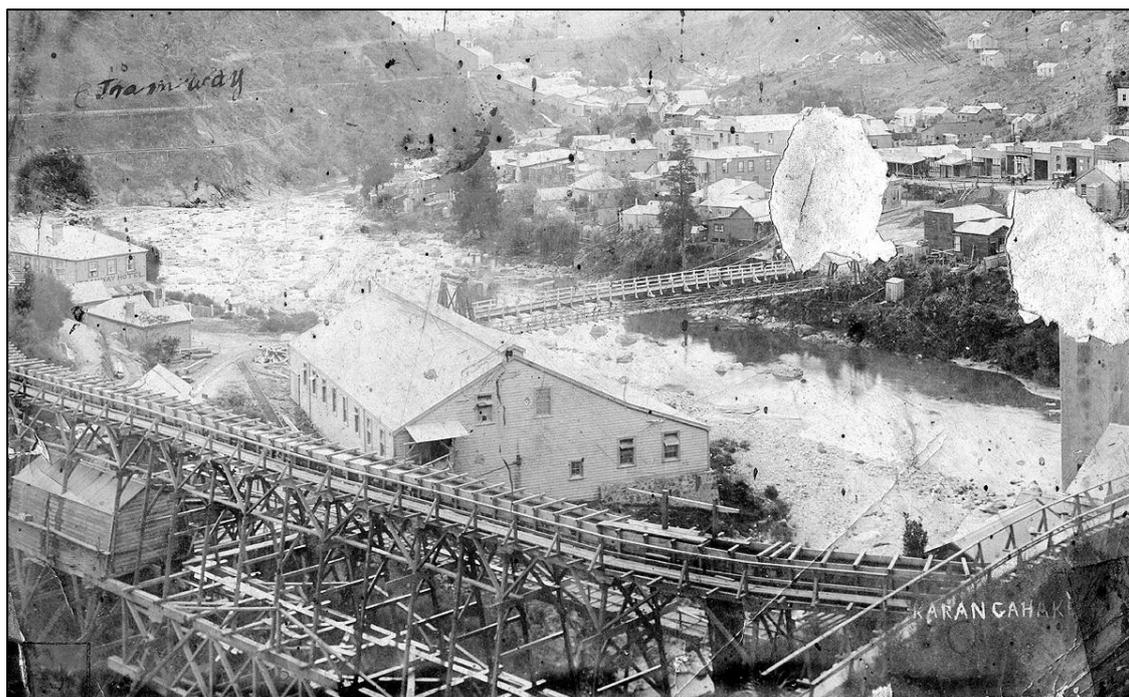
Staples collection. A similar date to previous photograph, 1901 or 1902.

Prominent in the foreground is the Crown Company's water race flume as it crosses the Waitawheta River. Notice the footpath beside the flume. The structure is supported on a box/girder.

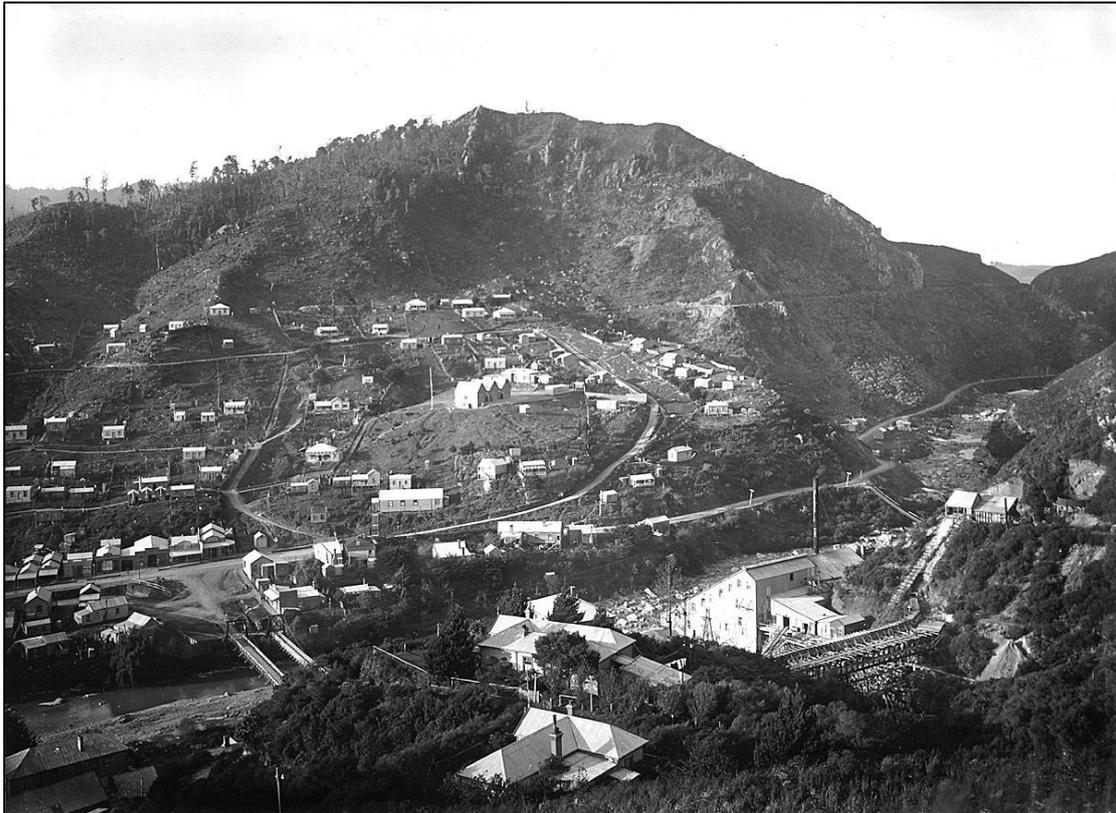
“The large bridge to carry the race is of the Platt type” can be seen bottom right, this side of the original Crown flume. Presumably it was to replace the old flume. It appears unfinished in this image, and there is little evidence that this new race was ever completed.

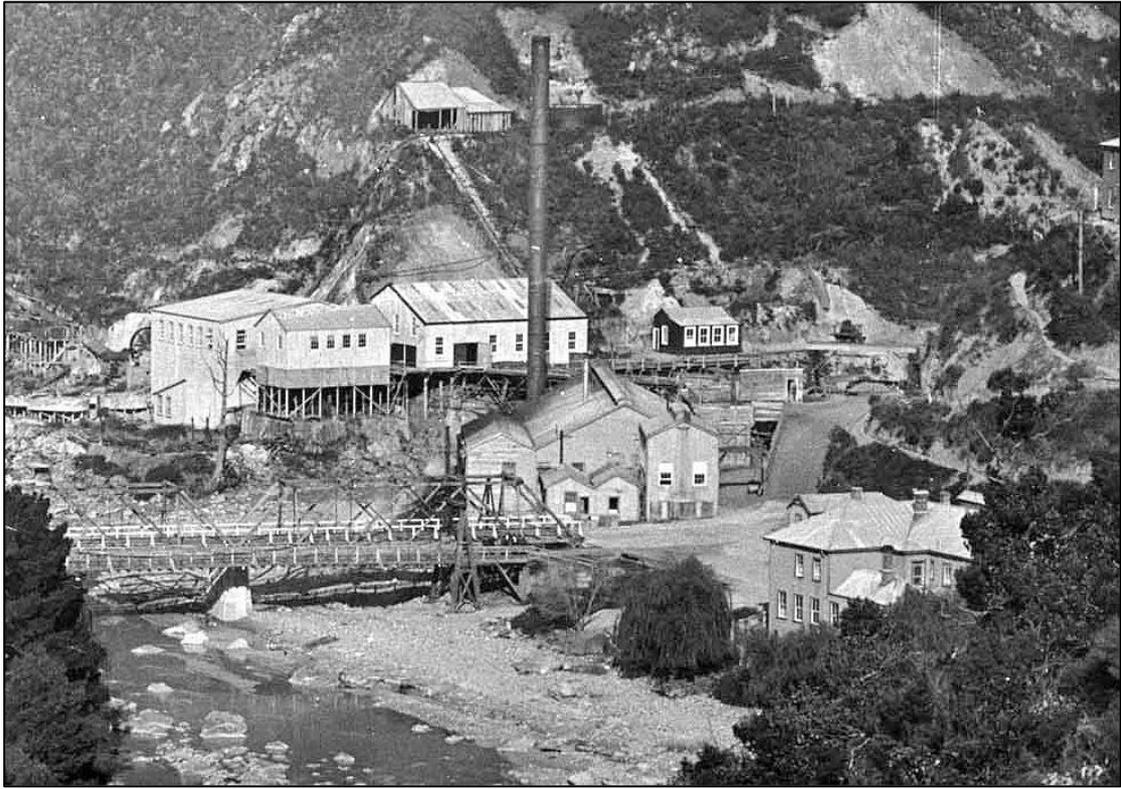
From a four image page, source lost.

The truss traffic bridge is complete, old suspension bridge remains, so 1913?

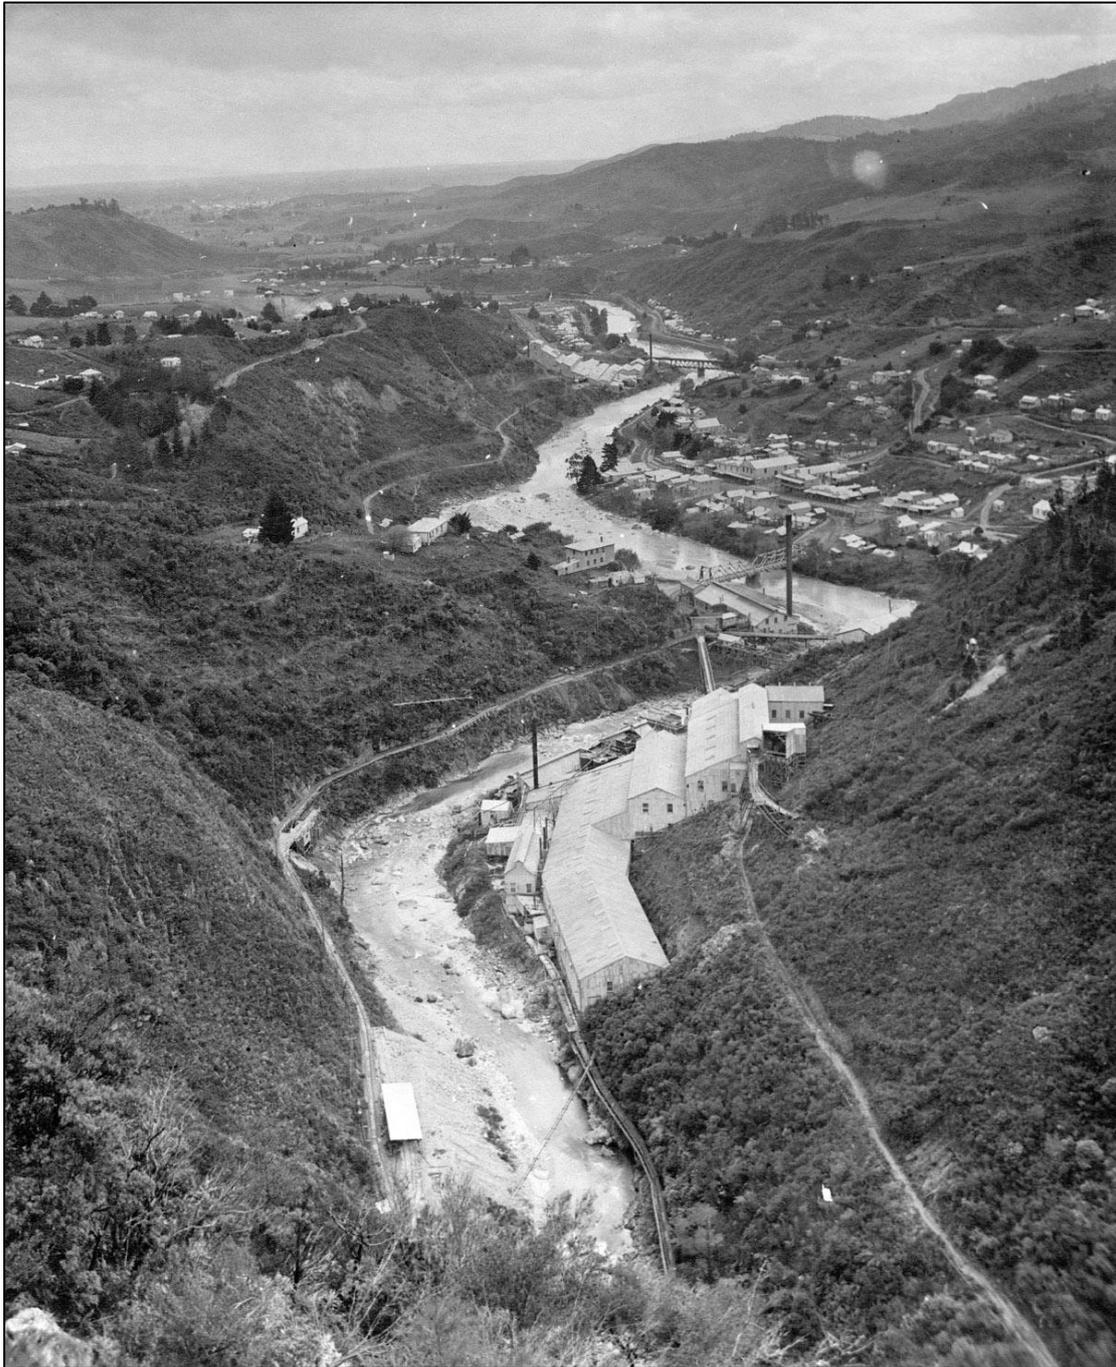
After 1913 bridge, suspension bridge removed. Before late 1915 when the two storey boarding house is removed.

Photograph taken from the Woodstock Blow area, may be No.8 Level.
