# Talisman battery site

## Talisman battery site

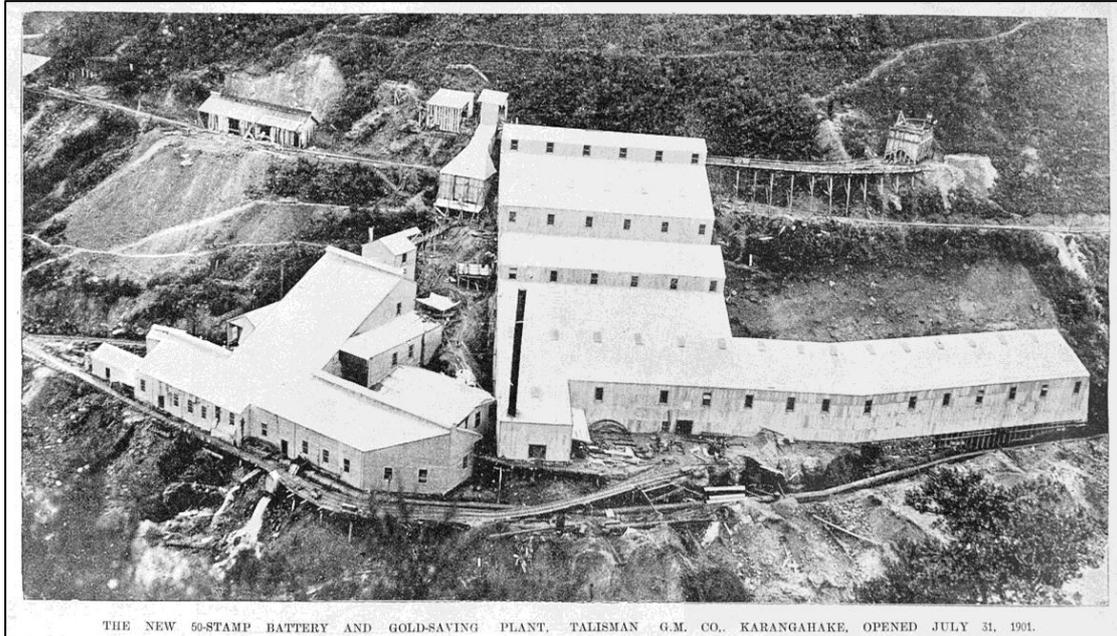
THE NEW 60-STAMP BATTERY AND GOLD-SAVING PLANT, TALISMAN G.M. CO., KARANGAHAKE, OPENED JULY 31, 1901.

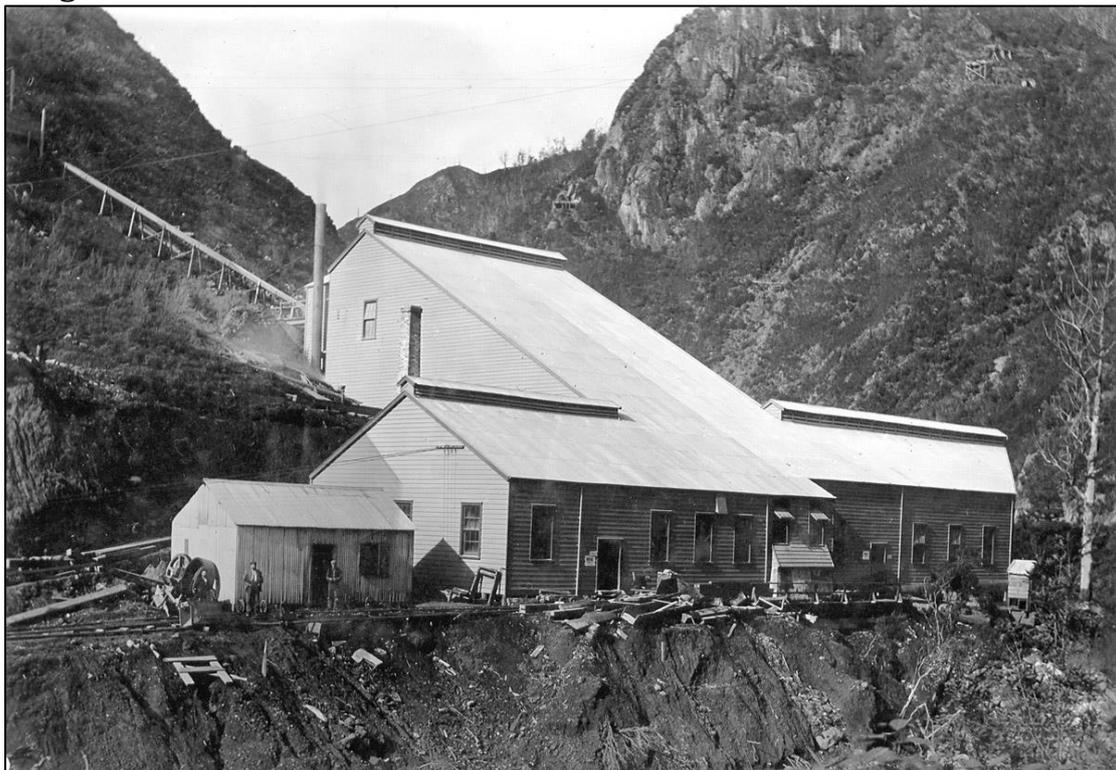
The earlier of two images of the smaller Talisman battery, based on the lack of the extra outbuilding of the next image. Photograph taken from across the Waitawheta River, on the Crown tramway. Staples Collection.

The two tone roof suggests that this is already the larger 20 stamp battery, with the right hand portion recently added? The pipe chimney, top left, must be from the ore dryer, and is discharging smoke. The additional ten stamps, and ore dryer, were erected late 1896, so the image is at least this.

For a short time the kiln was used. Ore was delivered to the kiln by cable, and brought into the battery via a tunnel under the kiln. We can see this just to the left of the round chimney. The kiln, replaced by an ore dryer within the building, is now a storage hopper. The wooden chute allows ore to bypass the kiln entirely.

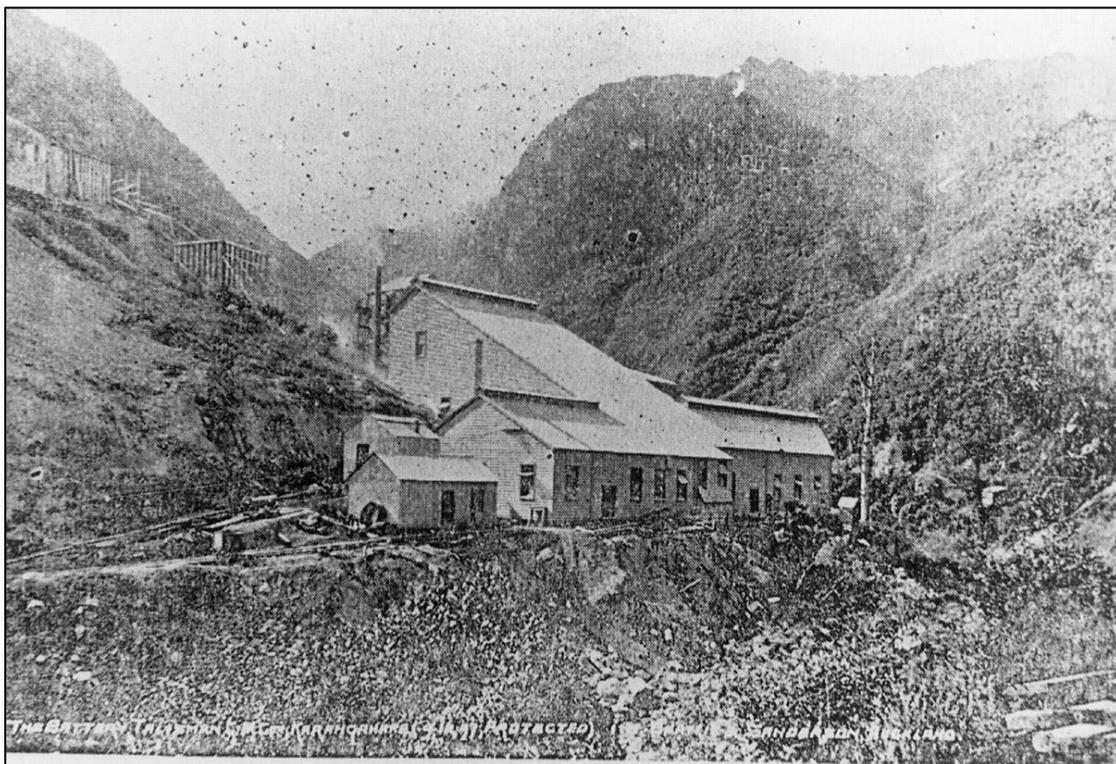
This mechanically reproduced image has 1897 in the file name, and may have that date printed in the text at bottom. There are small additions to the battery building, immediately behind the round chimney, and to the right of the main roof. These additions can be viewed from the other side in the image of the construction of the new battery September-October 1900.

A No. 5 Krupp ball mill, was installed in early 1898, and was expected to increase the crushing-capacity of the plant by at least 20 tons per day. This might account for one or more of the extensions.

What appears to be an ore hopper has replaced the chute, and maybe a building now covers the kiln (to keep the ore dry?). The hopper may collect ore directly from a cableway?

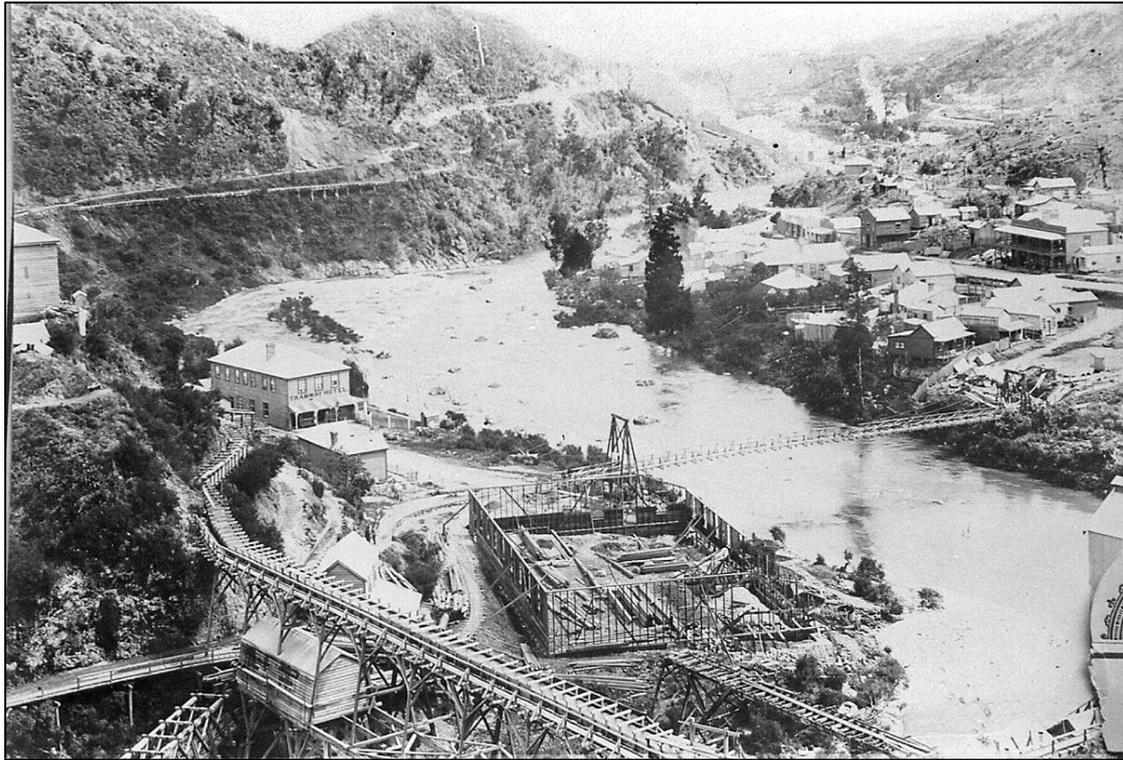
Talisman Vat House on Special Site under construction, early in 1897 <sup>50</sup>

Crown water race in foreground, to its right the remains of the tramway to the Ivanhoe battery  
(removed 1890).

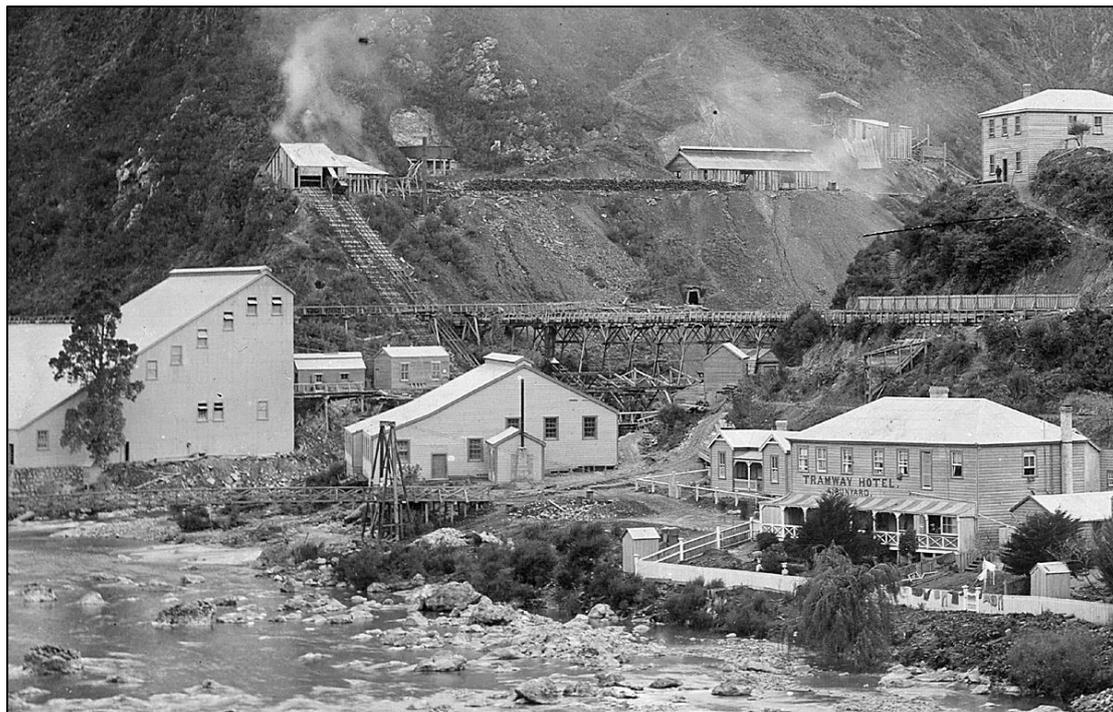
Talisman cyanide vat house on Special Site.

The cyanide plant consists of 6 wooden vats each 22 feet in diameter, with the usual accessories, including amalgamated copper plates and three 4-foot Berdans, and more.<sup>51</sup>

The cyanide plant on the special site consists of 6 wooden vats each 22 feet in diameter, with the usual accessories, including amalgamated copper plates and three 4-foot Berdans. The sumps are substantially built of concrete. The centrifugal and vacuum pipes on this site are driven by an electric motor operated by the dynamo on the machine site. Water for vat sluicing, etc, is brought to the special site from the Hauraki Creek by means of a pipe 3 inches in diameter. The turbines, dynamo, motor and electric light fittings were supplied by Messrs John Chambers and Son, Auckland, represented by Messrs Ernest Fenn and Frank Roach, who also constructed the substantial turbine pit. The water race was constructed by Messrs Seagar Bros., of Auckland. The remainder of the work was executed by Mr J. J. Payne, of Auckland.

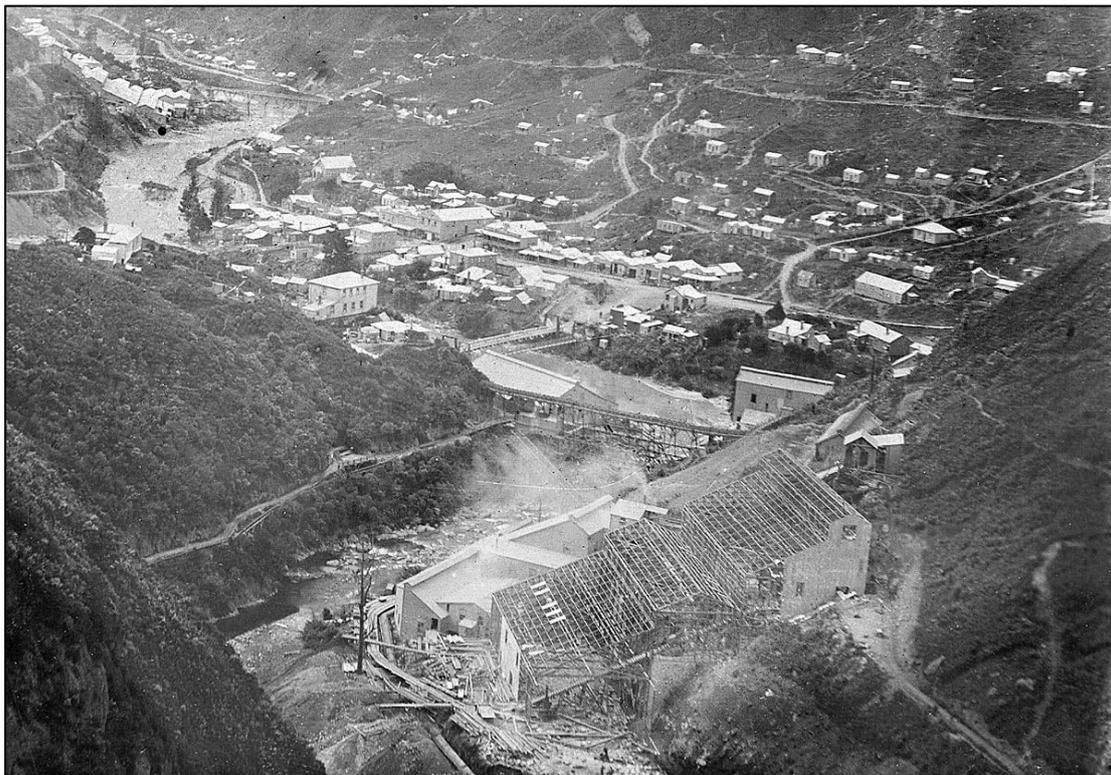
Construction of new 50 stamp battery. Old battery behind, vat house beyond the Crown Company water race.

Photograph taken from Plum Pudding/Woodstock Blow  
September-October 1900<sup>53</sup>

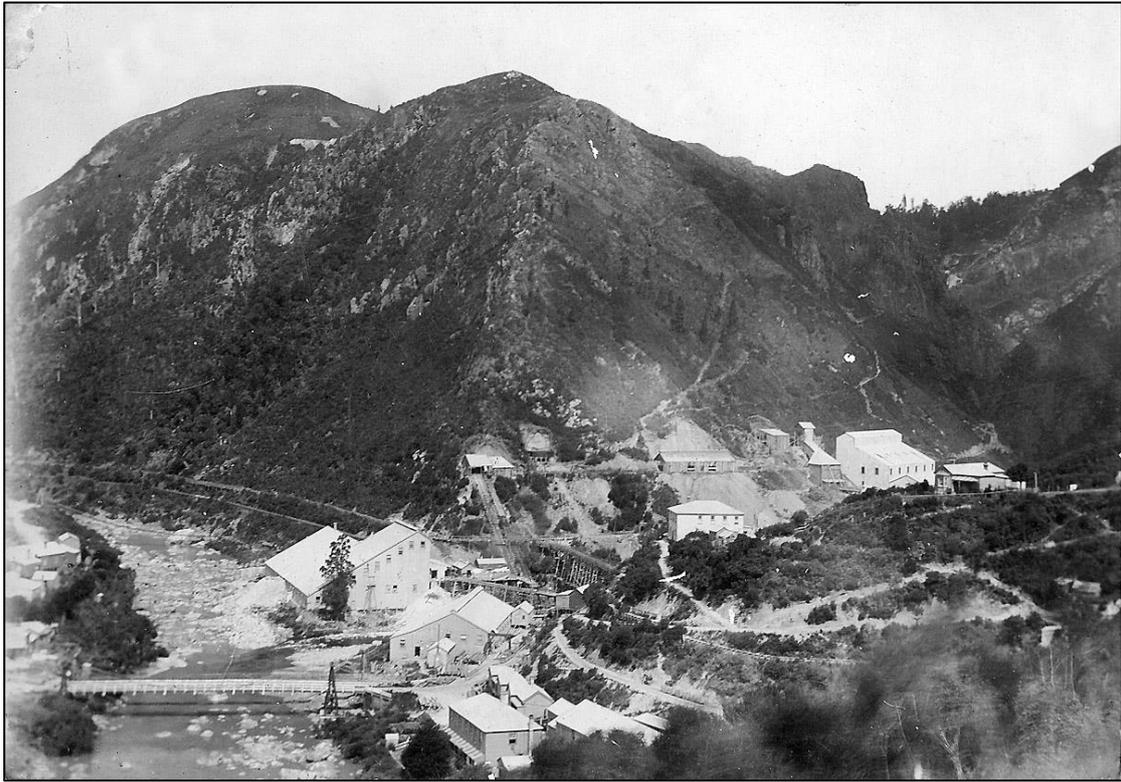
The new Talisman battery is complete, so late 1900 or 1901. There is no large chimney on the Woodstock battery; this was also erected late 1900, or 1901. So the larger Talisman battery is quite new in this image. The photograph is taken from the County Road.  
Note the suspension bridge across the Ohinemuri River, upstream from the Woodstock battery (early 1896).

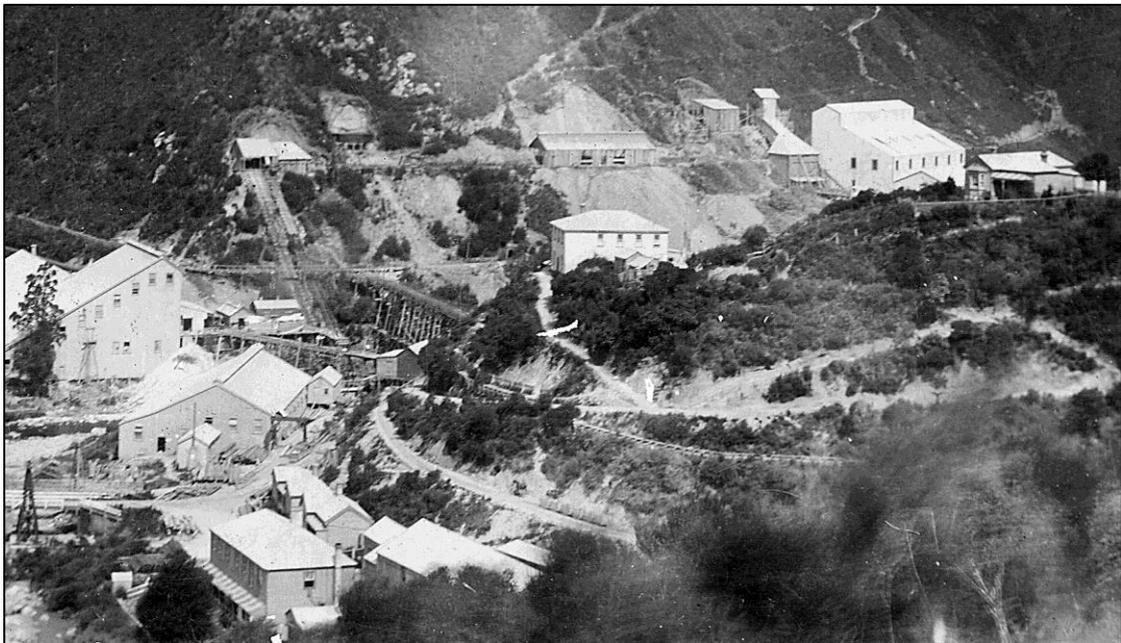
The Vat House remains relatively unchanged, but it has acquired a small building at the far right hand end (but it may be hidden in the earlier image).

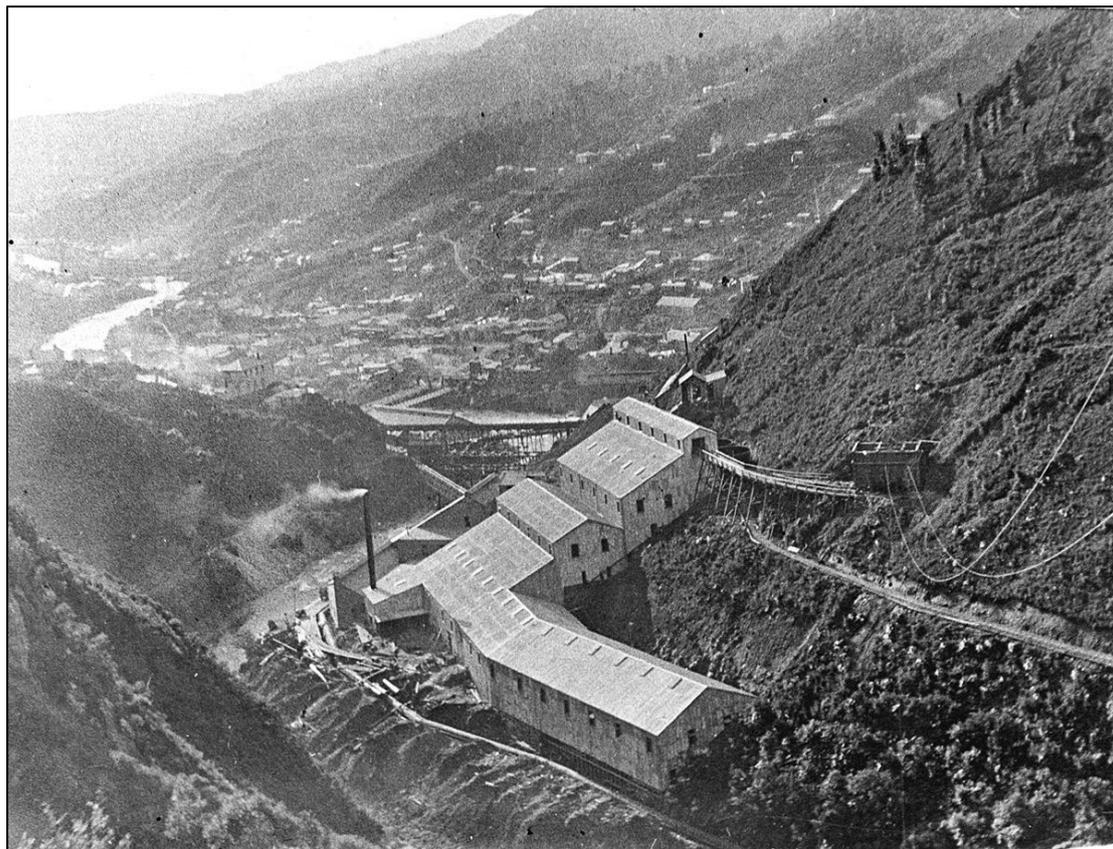
The Talisman battery viewed from beside and below a hopper from the No. 8 level. The battery hopper is well away from the battery, connected by a trestle tramway. This hopper will be moved to the battery building at a later date. There are two sets of cables delivering to the hopper; less obvious are the cables coming from the top of the image. Are they the control cables for this cableway, or a different cableway altogether?

There are two large vats to the right of the top of the battery building. Process water storage?

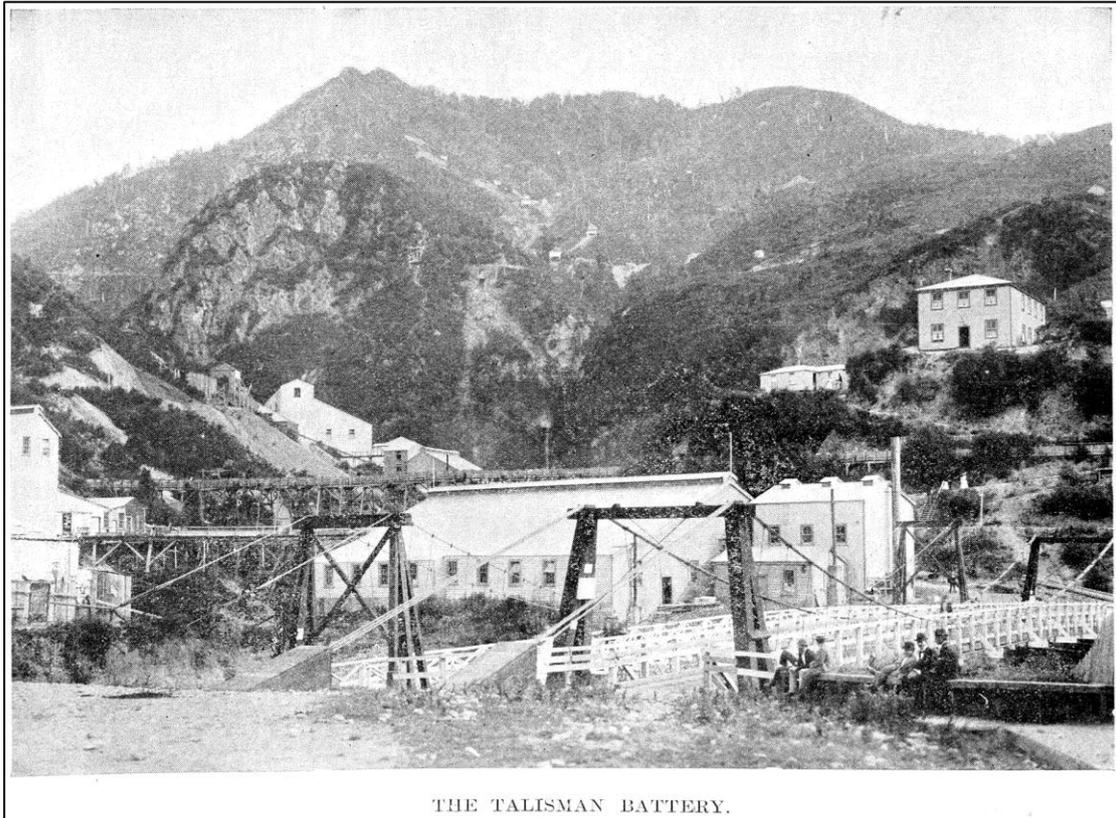
1902 03 22 Auckland Libraries Heritage Collections NZG-1902 03 22-0553-04  
A larger boiler house has been added, behind the small earlier one, to the right of the vat house.  
Two suspension bridges, six photo-bombers.

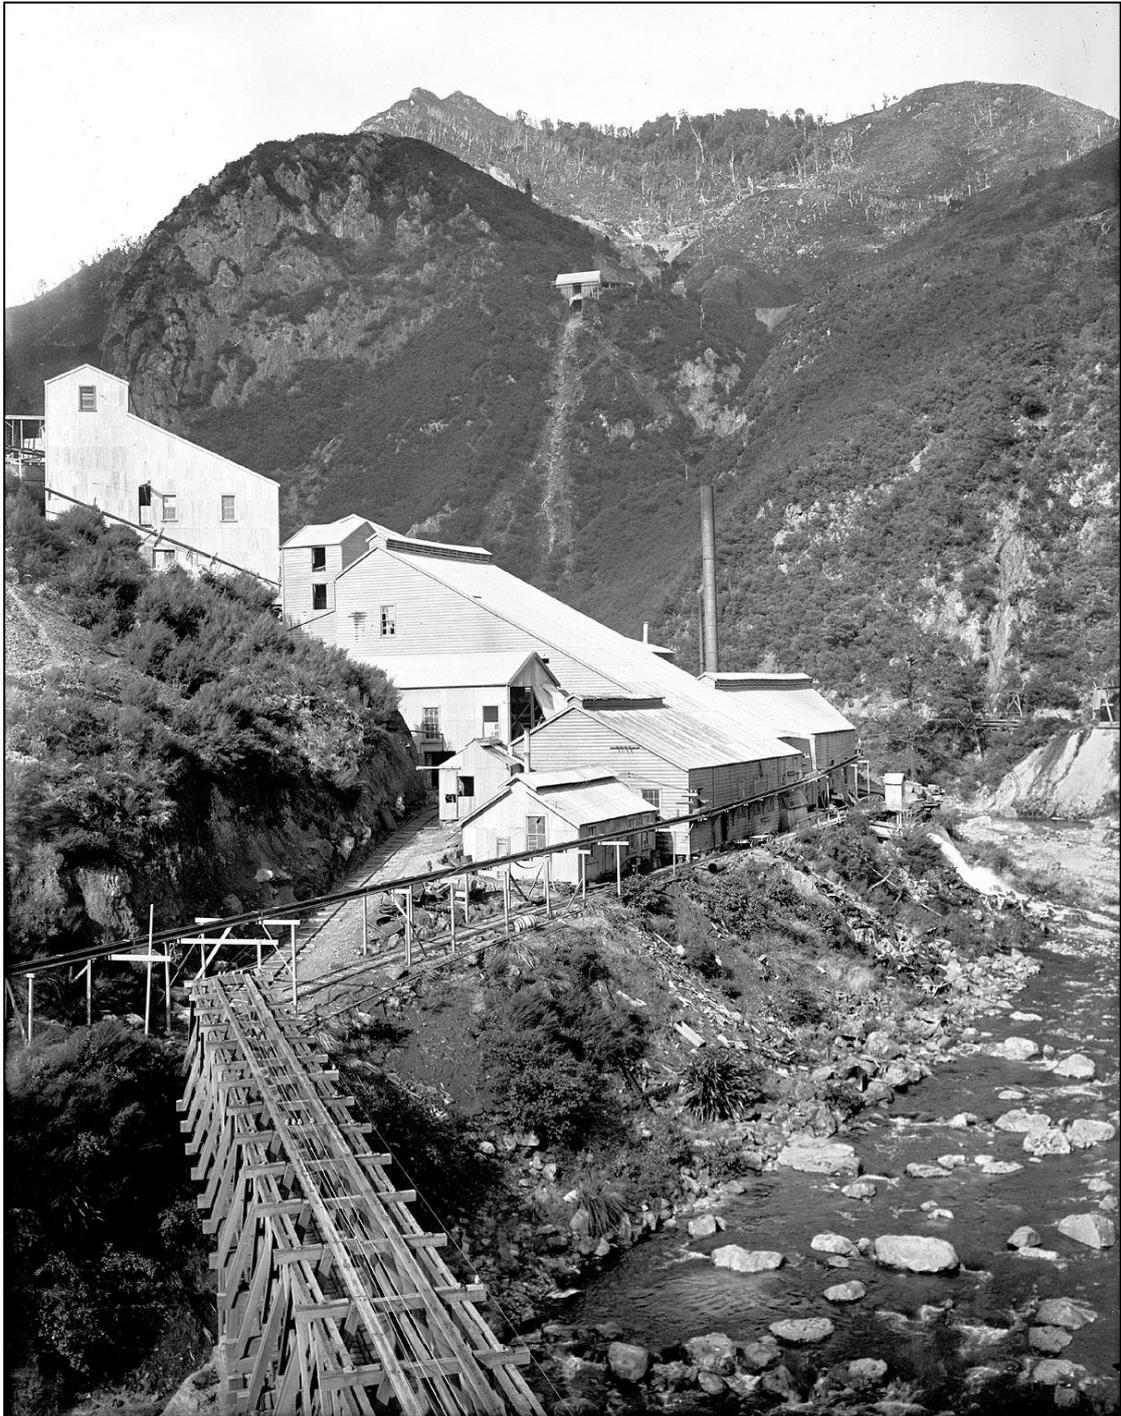
Photograph taken from the bank/headland above the Howe Truss bridge.

Additionally, a small pipe descends the hillside beneath the ore hoppers. Compressed air to No. 8 level?

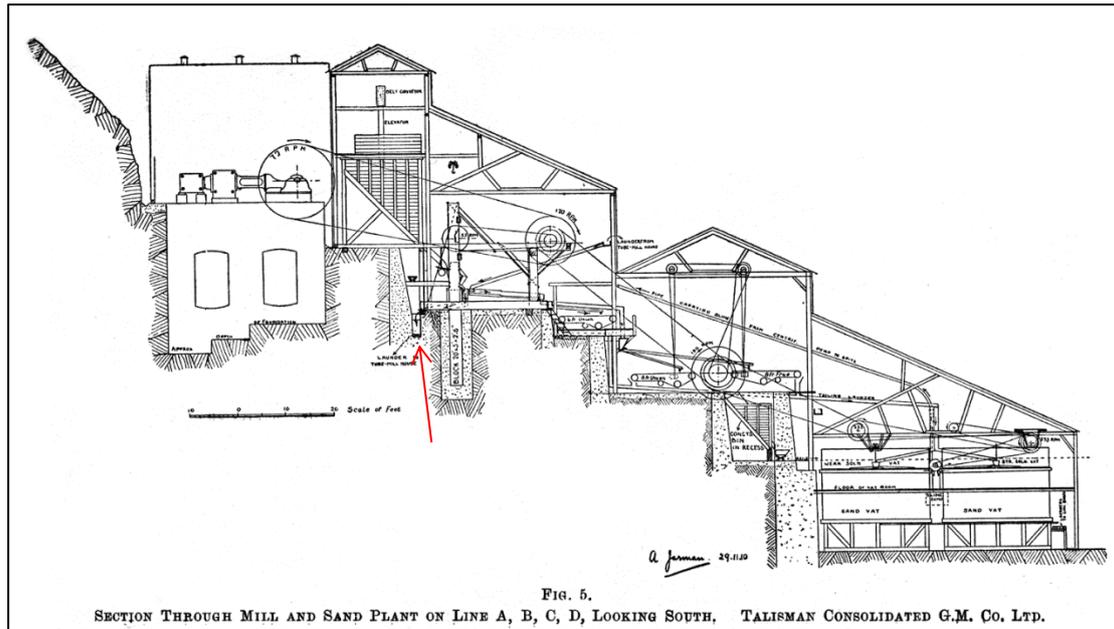
The new launder is arrowed.

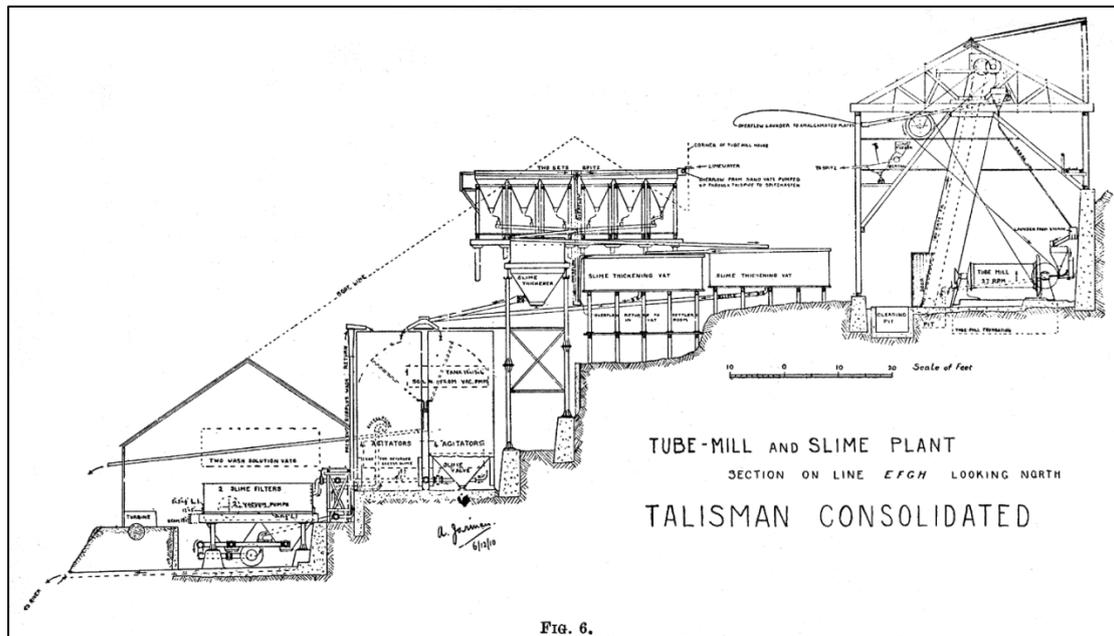
These cross-sections from Jarman 1910<sup>67</sup>. They contain a wealth of information.

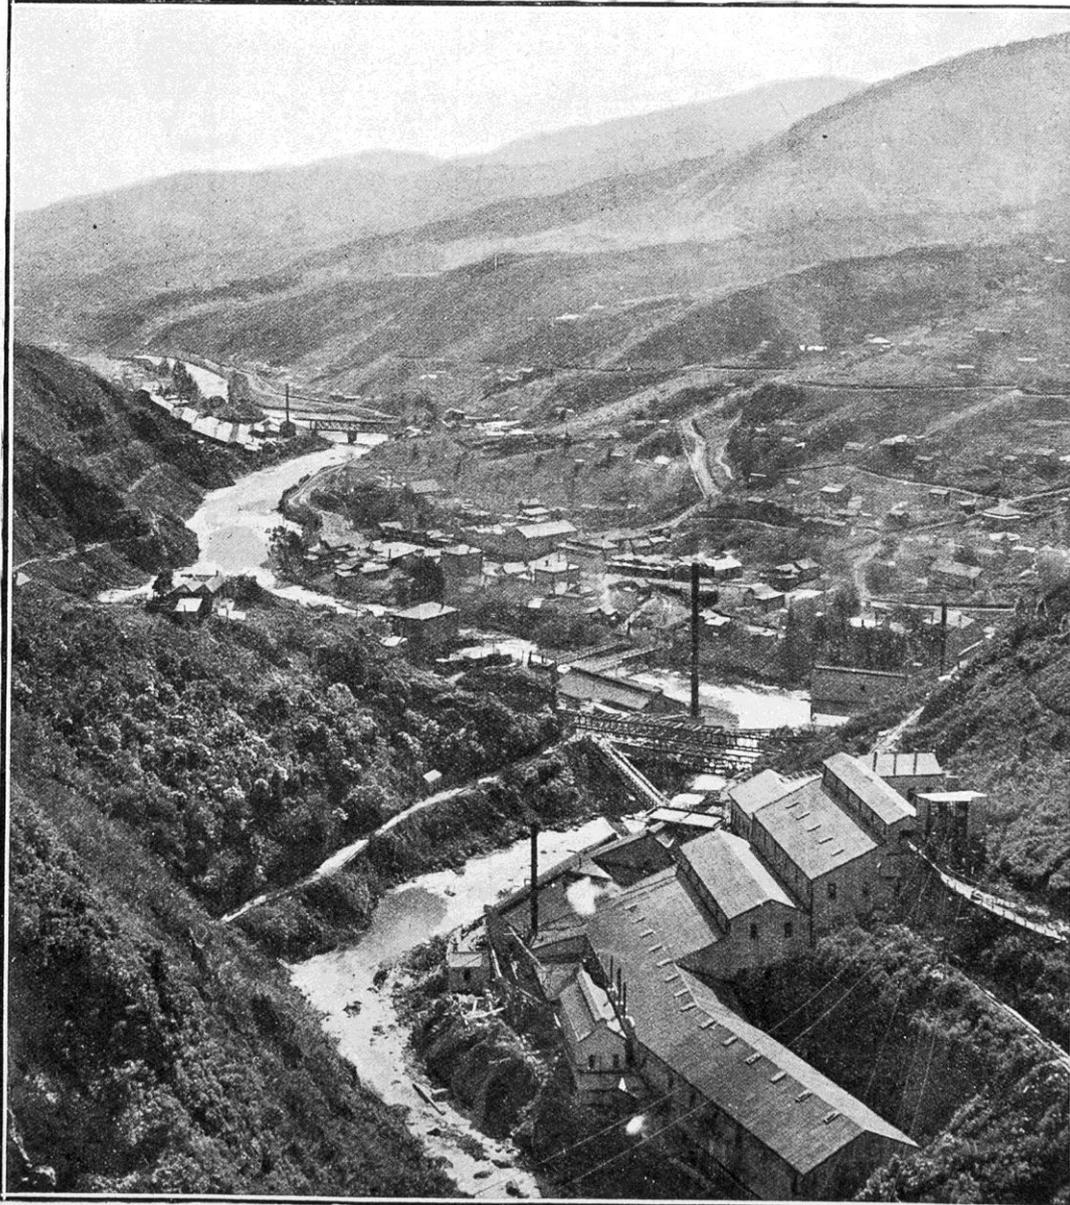
THE GREAT GOLD MINING INDUSTRY OF THE AUCKLAND PROVINCE: THE TALISMAN BATTERY AT KARANGAHAKE, SHOWING THE CROWN BATTERY ON THE LEFT.

The Crown water race flume is missing from the structures crossing the Waitawheta, and also from the bench that used to carry it to the battery.

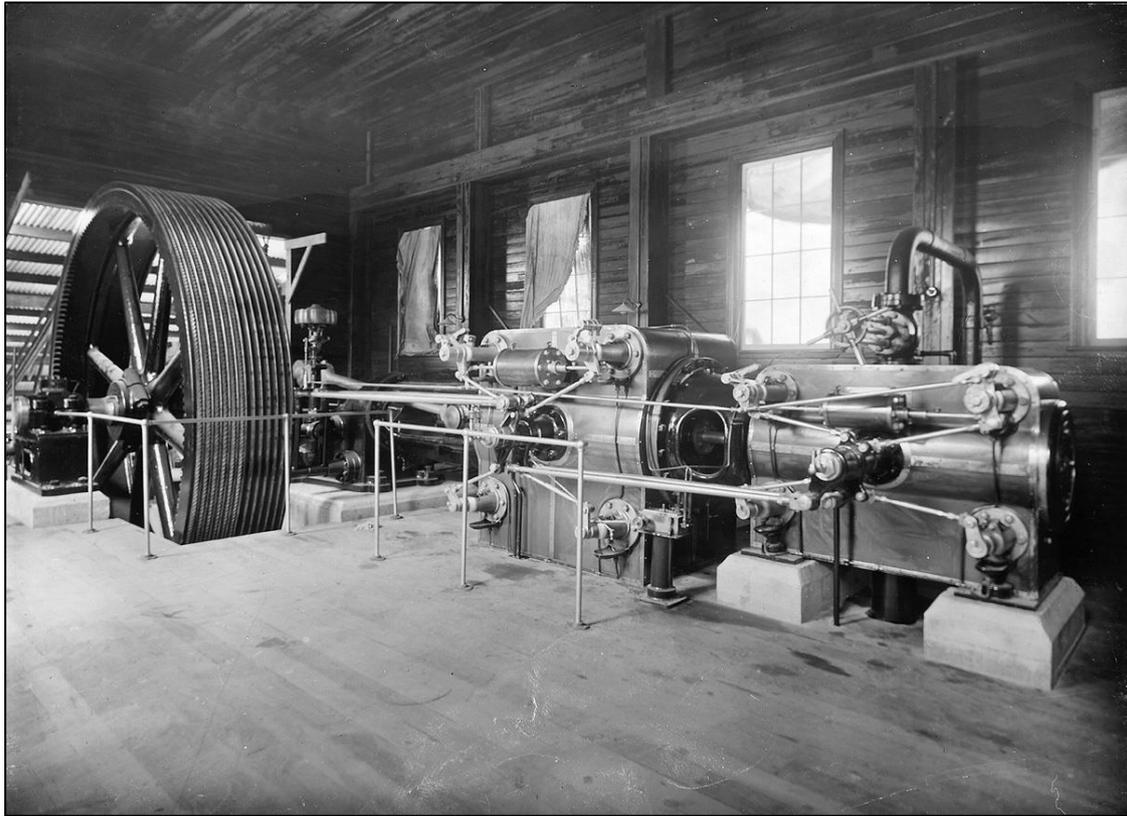
Talisman, compound tandem Corliss engine, 560 HP. Staples Collection. 1909 or a little later.

Compound in this case meaning a high and a low pressure cylinder.

The massive foundations of this engine, the main shaft and connecting rod remain today. The walkway passes through the right hand concrete mounting blocks.

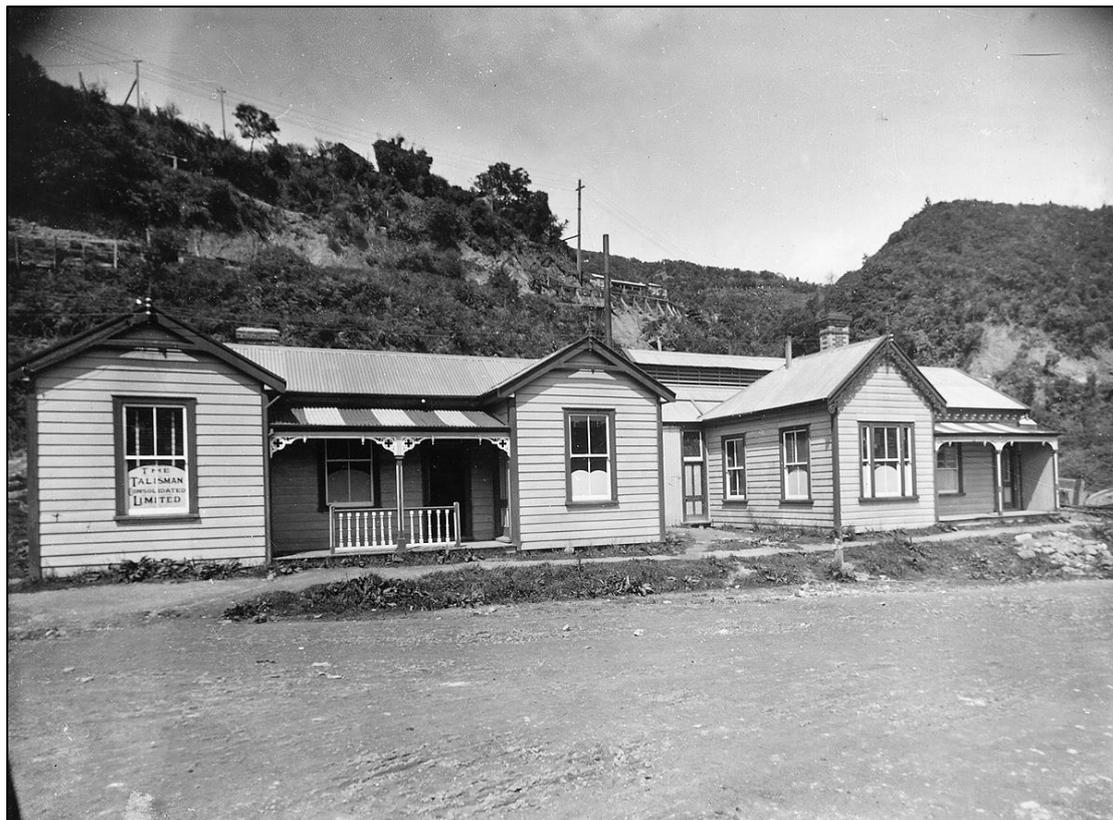
Talisman G.M.Co. Office and Assay room, 1909 W4802. Winkelmann photograph.

Opposite the two swing bridges were these three buildings. On the left the General Office, right office, and behind the Office the Assay House.

Assay house built later than the Office.

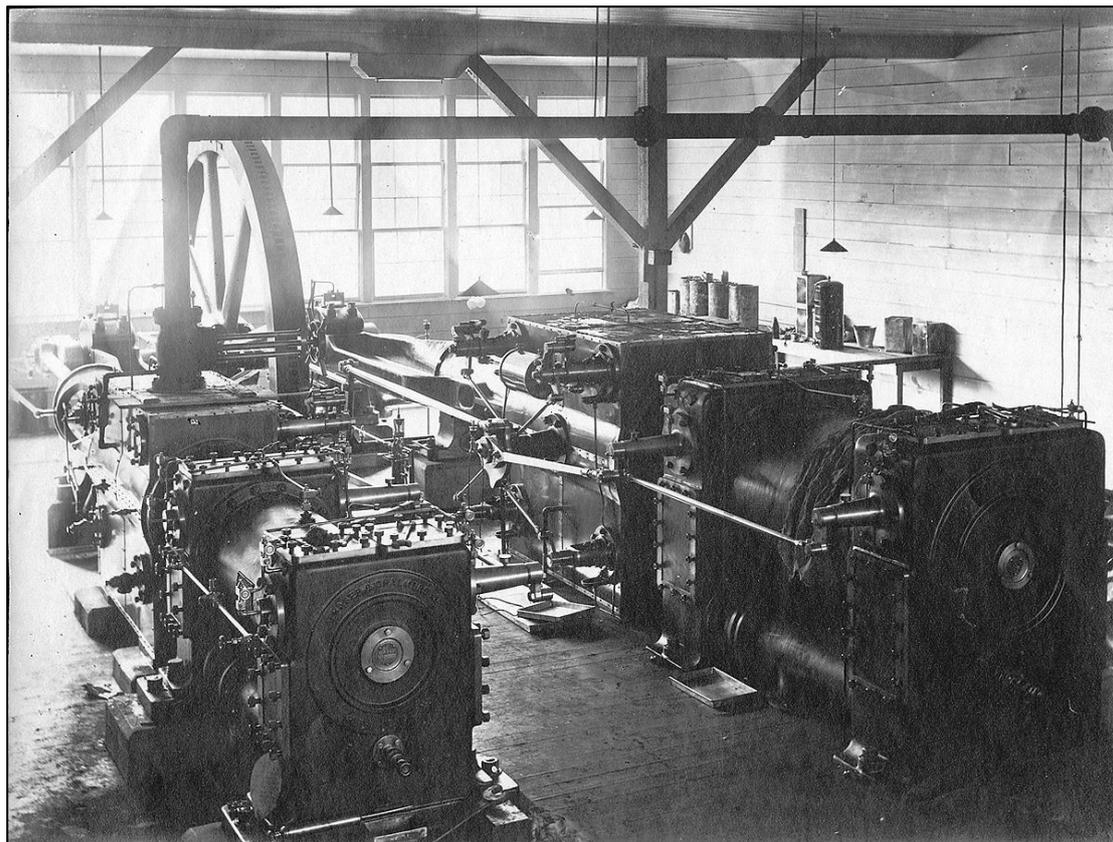
Talisman compressor, in the Powerhouse. 1908<sup>70</sup>

Mounting bolts and massive concrete foundations remain today. The windows in the background suggest that this installation is in the upstream end of the windowed addition to the powerhouse. This windowed addition to the powerhouse may be specifically to house the compressor(s). The boilers were installed in the main building (the expanded version of the original Vathouse).

An Ingersoll Rand compressor to be installed beside the Riedler, in the downstream section of the windowed building. Hence the second pair of concrete foundations. This machine installed 1911.<sup>76</sup>

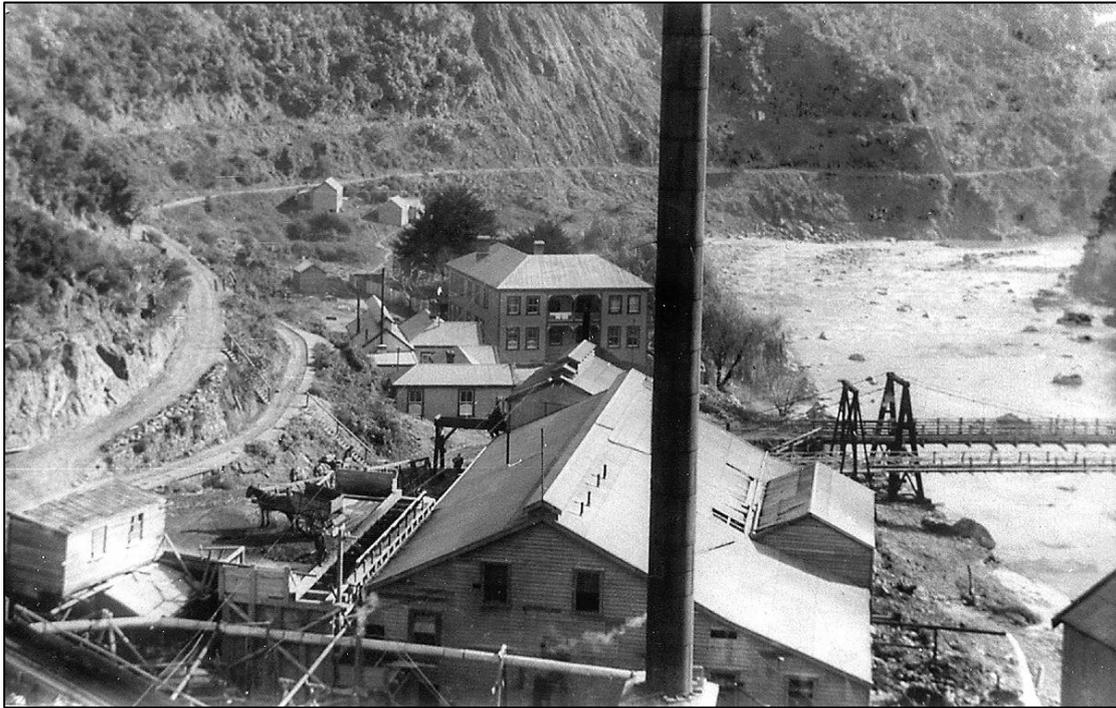
Talisman powerhouse, completed late 1908.

Hotel has been replaced after 1906 fire. The assay rooms have been added, so 1909 or shortly after. No soot on the roof yet.

The light coloured pipe in the foreground is the steam pipe heading to the new engine at the battery.

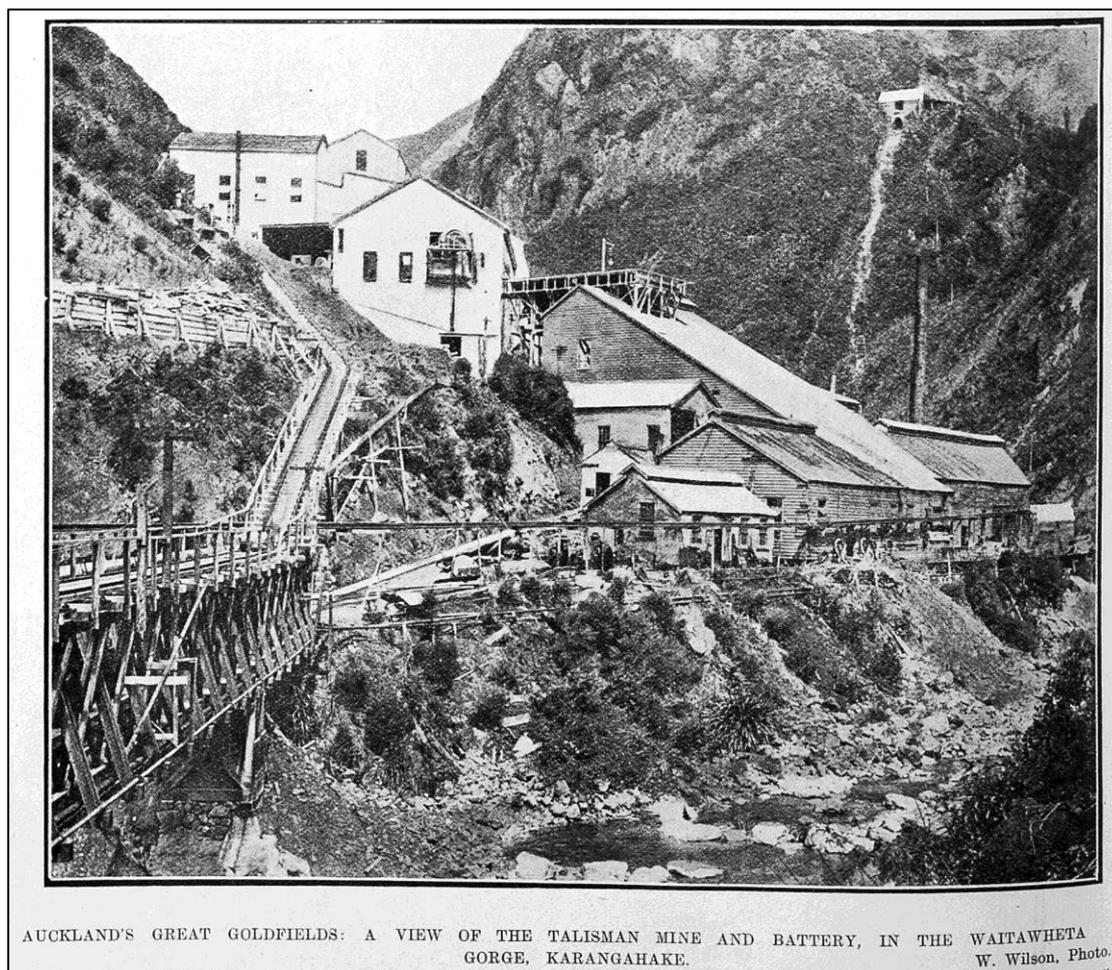
The large steam engine is installed in the new building top left. Foundations and crank shaft remain today. The top of the double decker bridge has been extended to an incline to facilitate its transport to the battery.

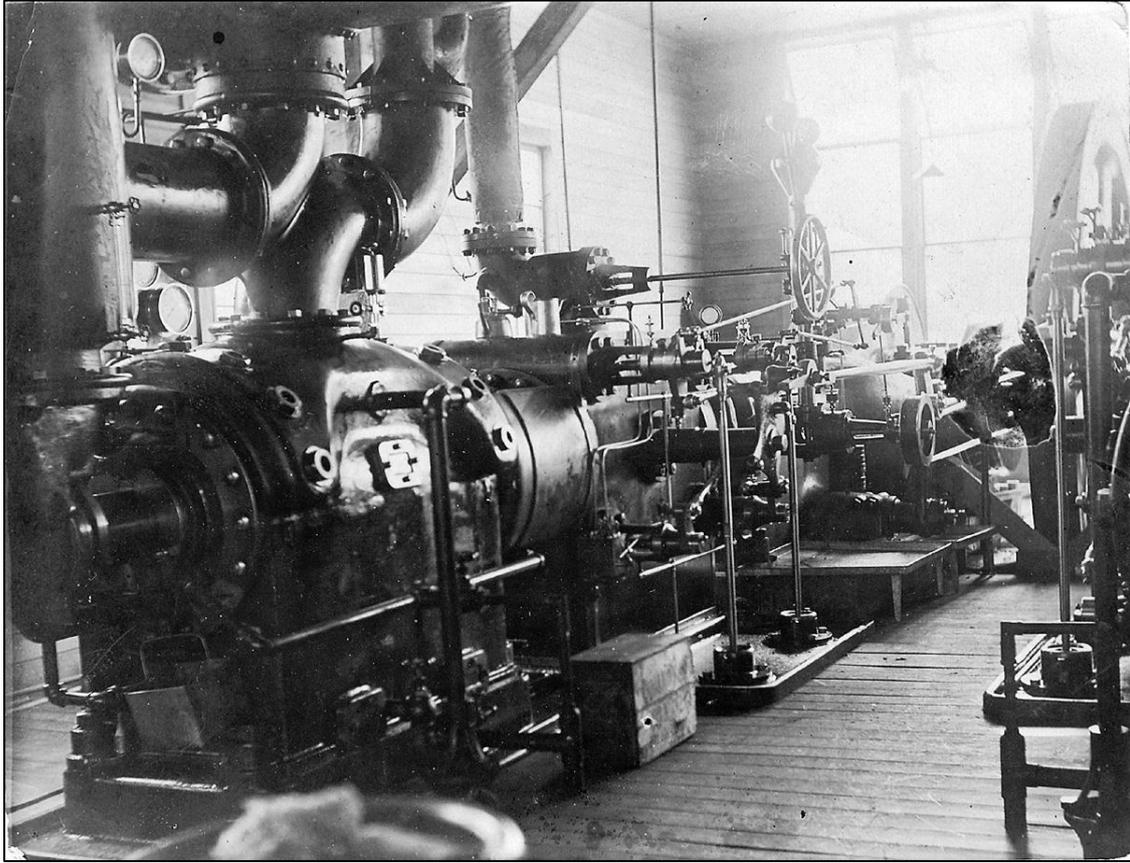
This may be the second compressor, installed 1911. It may also be a duplex machine, steam powered, only half being shown here. It appears not to be a Fraser and Chalmers compressor. Ingersoll Rand<sup>86</sup> identify their machines on the air output pipe, which we can't see (see compressor in the Woodstock document).

The windows behind indicate it is installed in the Talisman powerhouse.

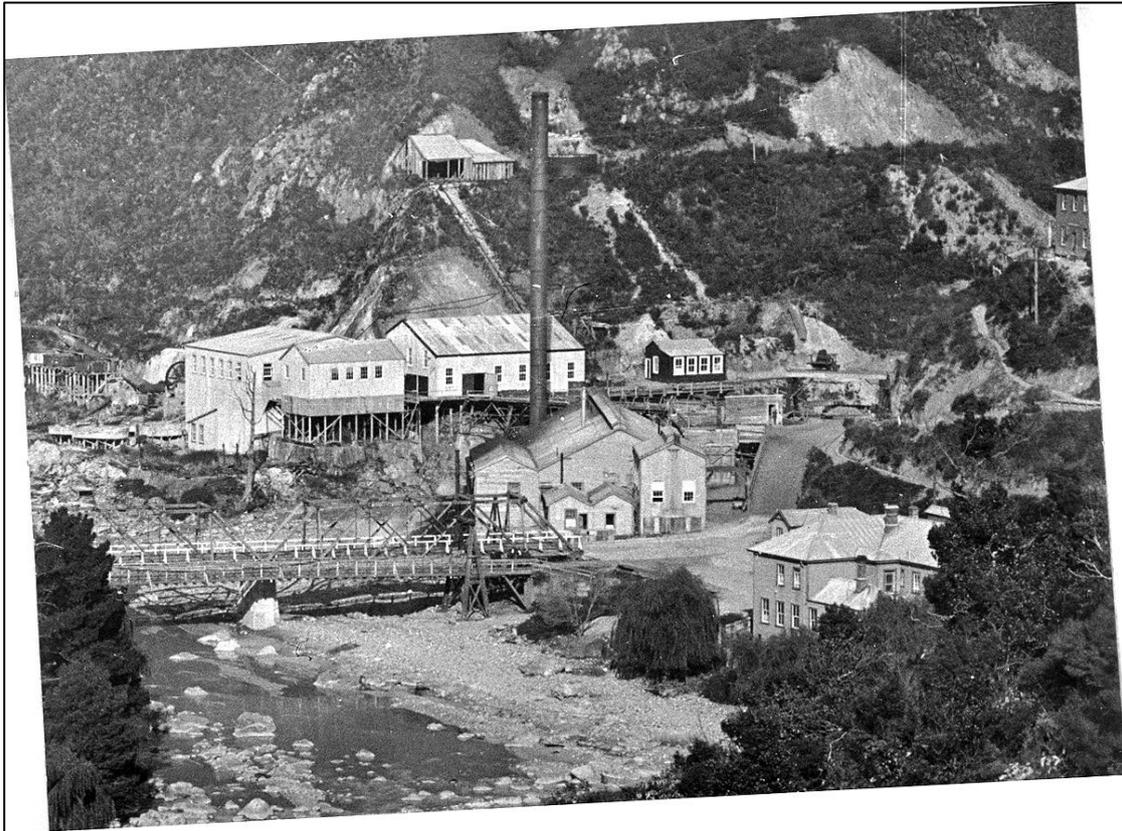
After 1913 (truss bridge), but the suspension bridge remains.

The Woodstock battery buildings burnt down in 1910. The replacement buildings seen here house air compressors powered by water from the Ohinemuri race.

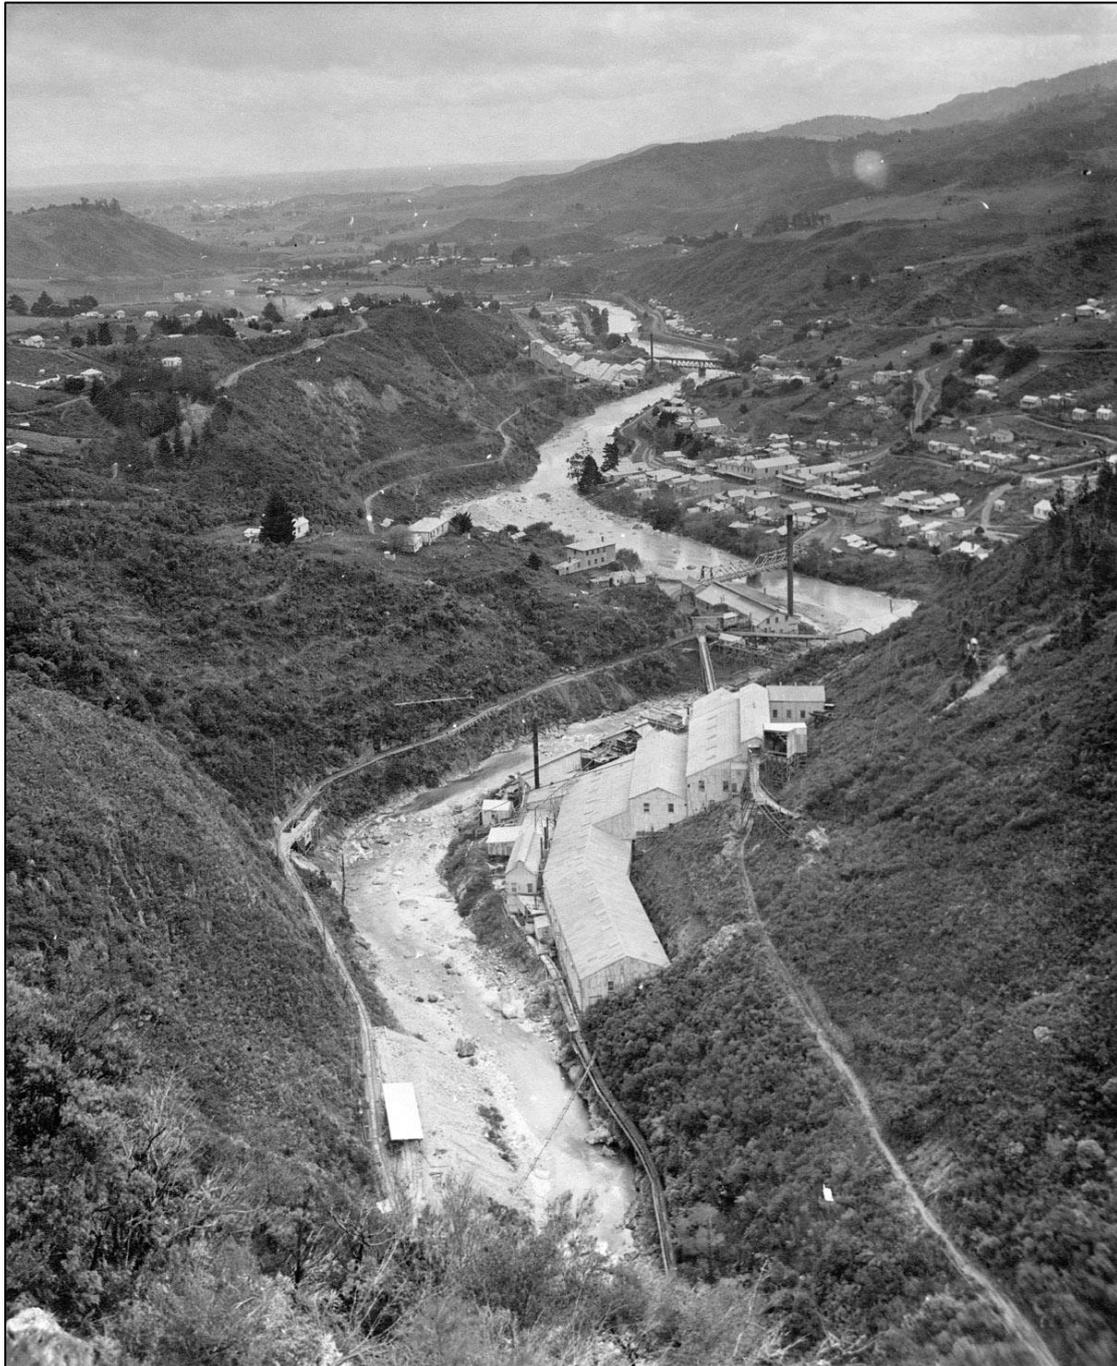
1915?

Engine in place. After 1913 bridge, suspension bridge removed. Before late 1915 when the two storey boarding house is removed.

Photograph taken from the Woodstock Blow area, may be No.8 Level.
