# Talisman battery site

## Talisman battery site

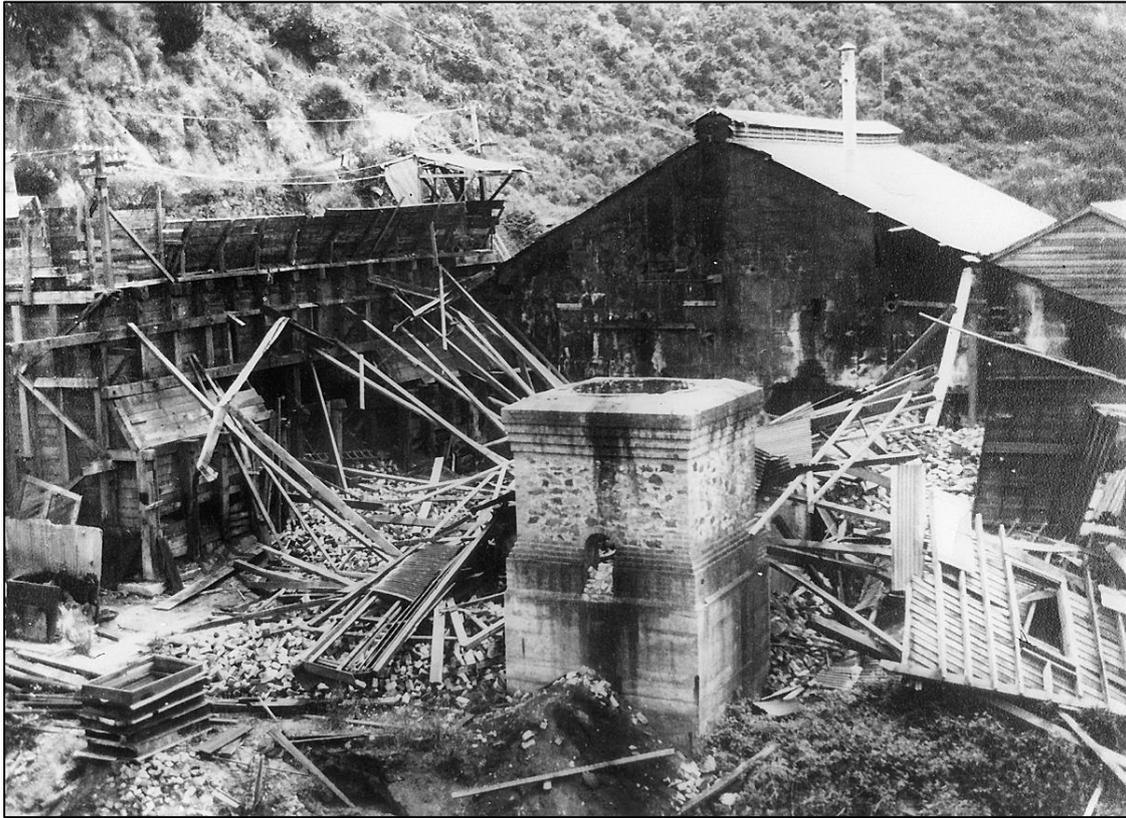
Talisman Powerhouse under demolition. Circa 1927. ATL.

Viewed from the Woodstock battery side of the Waitawheta River, the massive foundation of the chimney is prominent. The piles of bricks suggest the boilers (4) have been removed. To the left are the coal hoppers, behind them the original vat house, and to right the compressor building.

In front of the chimney foundation can be see a pile of soot and or ash that had been discharged from the aperture halfway up the foundation.

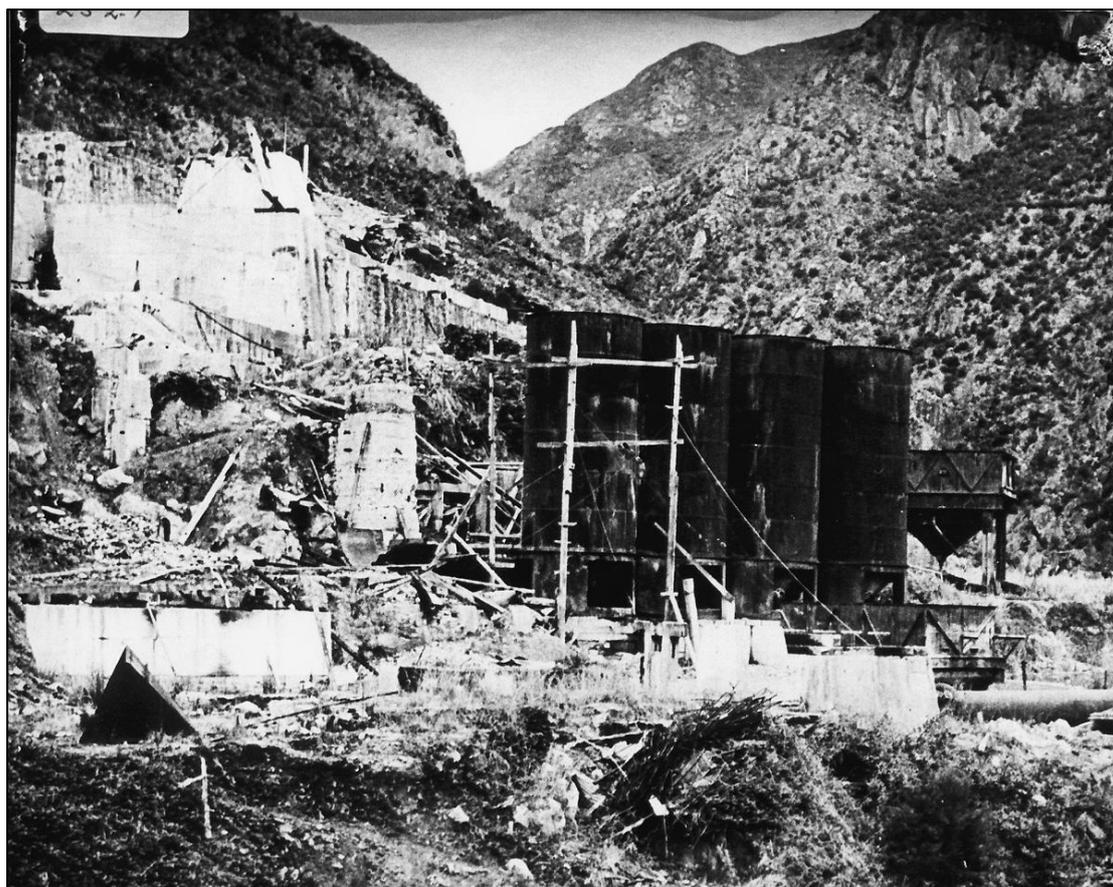
Talisman battery under demolition.

c. 1928

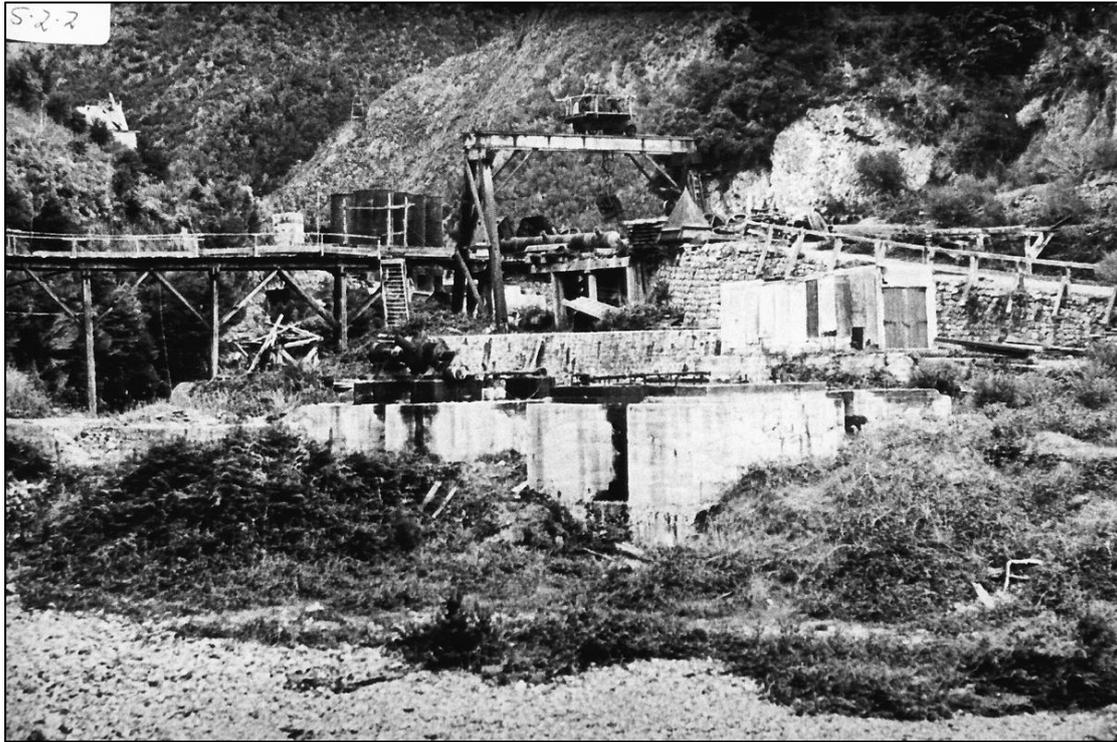
Talisman powerhouse under demolition. c. 1928

Foundations of the air compressors in the foreground, air agitation tanks at the battery in the background.

The concrete foundations/mounts we see today have been partially destroyed, possibly quarried during the construction of the Dubbo mill, c.1937. A 1938 photograph in the New Zealand Herald shows the damage done.<sup>92</sup>
